CORROSION BEHAVIOR INVESTIGATION OF MARINE GRADE MILD
STEELS IN THE BAY OF BENGAL WATER ENVIRONMENT

A Thesis Submitted in Partial Fulfillment of the Requirements for the Degree of Master of
Science in Department of Naval Architecture and Marine Engineering

DEPARTMENT OF NAVAL ARCHITECTURE AND MARINE ENGINEERING
MILITARY INSTITUTE OF SCIENCE AND TECHNOLOGY
DHAKA, BANGLADESH

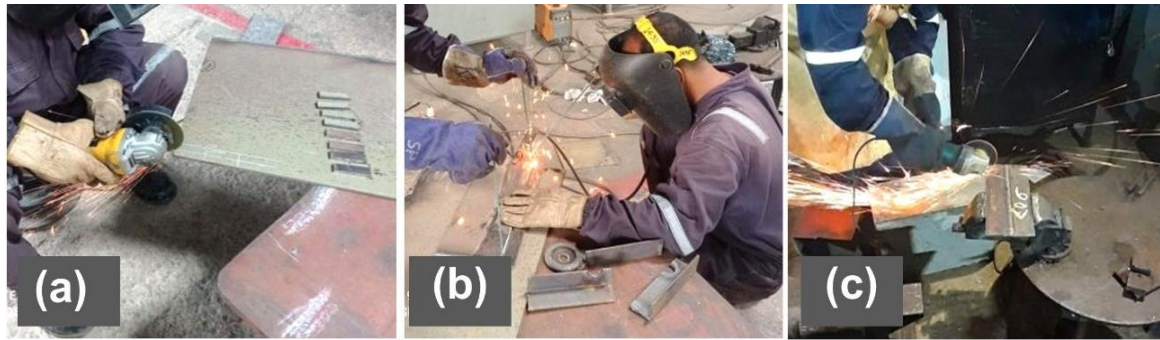
Figure 2.1: Cutting and sizing of the coupons in BN Dockyard Shop: (a) sample cutting, (b) butt welding of the samples, (c) cutting of welded metals

The process involved a two-step approach: firstly, the plates were cut to rough dimensions in the Platter & Welding Shop. Figure 2.1 illustrates the initial stage, where raw mild steel sheets were cut into standard-sized coupons and the butt welding of the metals were done. After the cutting the metal pieces were refined to the final required size using a CNC cutting machine located in the machine shop of the same dockyard, shown in Figure 2.2.

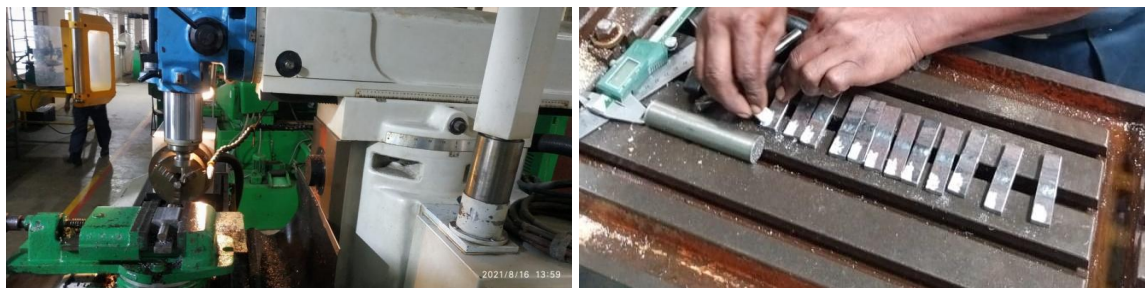
Figure 2.2: Machining of the coupons in the CNC Cutting Machine of BN Dockyard.

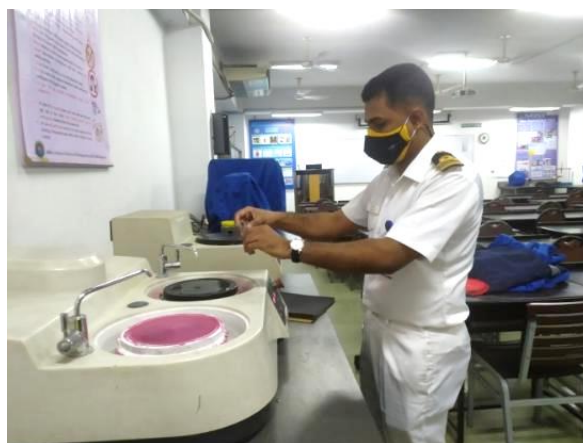
Figure 2.3: Polishing of the Metal Samples.

Once dry polishing was complete, the samples were subjected to wet polishing using alumina paste which further enhanced the surface quality, bringing it to a near mirror-like condition. This final stage of polishing is essential, as a highly polished surface is required for accurate and consistent corrosion testing. Upon completion of the wet polishing, the steel samples were carefully rinsed and dried in the same Metallurgical Laboratory at room temperature, utilizing natural convection. Special care was taken to avoid contamination or oxidation of the freshly polished surface during the drying process; A thorough and meticulous record of each prepared sample was maintained for reference during the subsequent stages of experimental investigation, ensuring all samples were in prime condition for detailed corrosion behavior analysis.

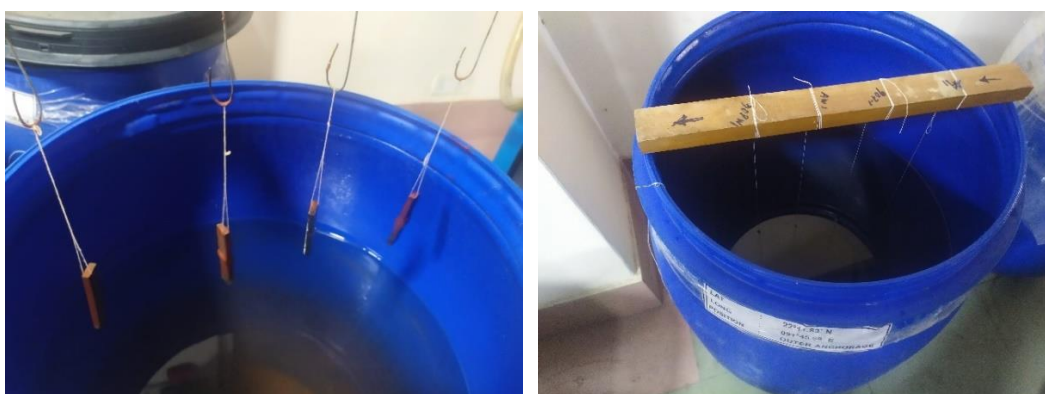
Figure 2.6: Immersion of the metal specimens in the stored seawater for gravimetric analysis

It is important to note that the prepared mild steel (MS) coupons were fully submerged in the seawater-filled barrels and kept at room temperature for the entire duration of the analysis. As shown in Figure 2.6, the coupons were immersed completely to avoid partial submersion, which could lead to uneven corrosion patterns and compromise the integrity of the results. Additionally, to prevent contact between the coupons and the barrel walls—thus avoiding contamination or other factors that could influence corrosion—the samples were suspended in the middle of each barrel. This arrangement ensured uniform exposure to seawater, enabling a controlled study that could be generalized to reflect the conditions found in the Bay of Bengal.

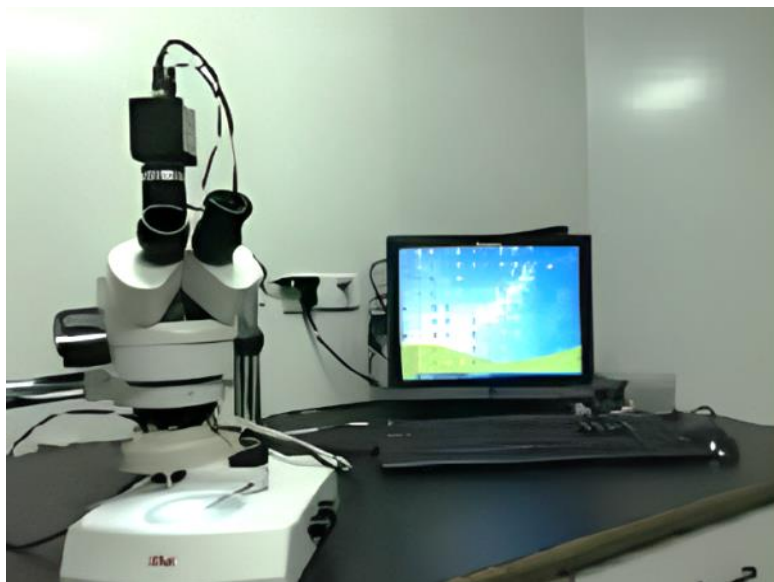
Figure 2.7: Optical Electron Microscope (Model: MM 500T)

Prior to the immersion process, the prepared mild steel samples underwent microstructural analysis using the Optical Electron Microscope (OEM) (Model: MM 500T) available at the Metallurgical Lab of MIST, shown in Figure 2.7. This advanced microscope, equipped with a computer interface, enabled detailed investigation of the samples' microstructure and surface topography. Conducting this analysis was essential to establish the initial state and condition of the samples before subjecting them to the corrosive effects of seawater.

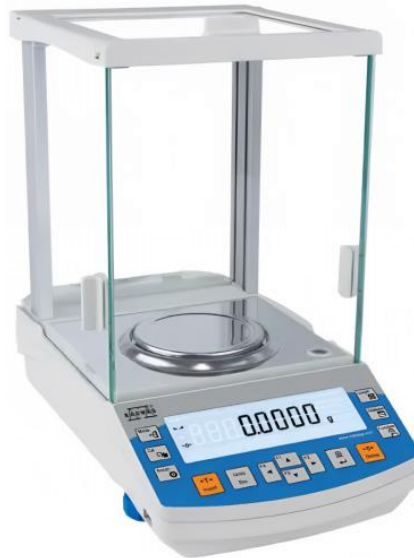
Figure 2.8: RADWAG Precision Weighing Machine with accuracy of 0.00001g

Following the microstructural examination, the precise weight of each sample was measured using a 'RADWAG Precision Measurement Analytical Balance,' shown in Figure 2.8, renowned for its exceptional accuracy. This analytical instrument can measure weights with a precision ranging from 0.0001 to 0.00001 grams. By carefully recording the initial weight of each sample, the study ensured that any weight changes resulting from corrosion during the immersion period could be monitored with a high degree of accuracy, allowing for precise quantification of corrosion effects.

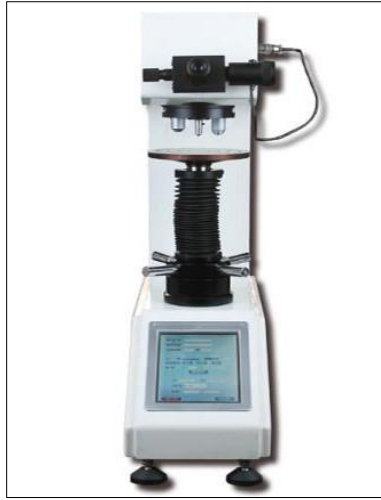
Figure 2.10: Micro-Vickers Hardness Tester (TMHV-1000DTe)

Thus, to determine the effects of corrosion on the mechanical properties of the mild steel samples, a comprehensive mechanical condition test was conducted by measuring micro-hardness values before and after the experiments in the corrosive seawater environment. The Digital Micro-Vickers Hardness Tester TMHV-1000DTe, illustrated in Figure 2.10 was employed, using a force of 5 kg with a holding time of 10 seconds. This testing method assesses the material's resistance to indentation, providing insights into surface hardness alterations due to corrosion processes.

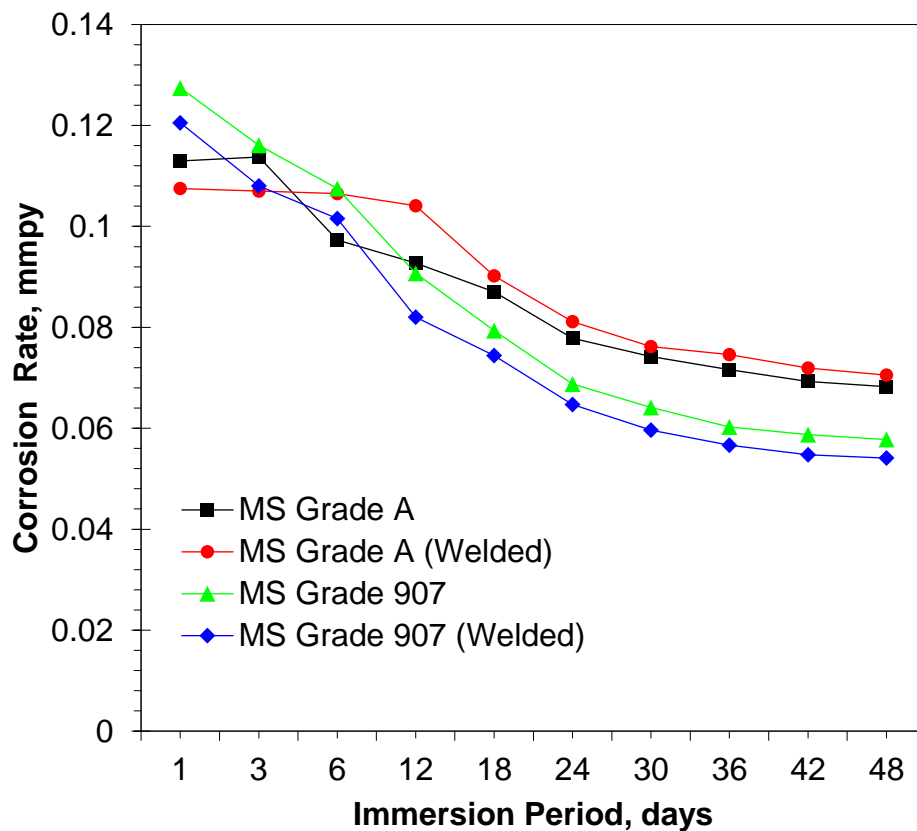
Figure 3.4: Corrosion Rate vs Immersion Period curve for Outer Anchorage Seawater

Materials	Highest Corrosion Rate (mmpy)	Lowest Corrosion Rate (mmpy)
MS Grade A	0.11374	0.06823
MS Grade A (Welded)	0.10749	0.07052
MS Grade 907	0.12743	0.05776
MS Grade 907 (Welded)	0.12052	0.05408

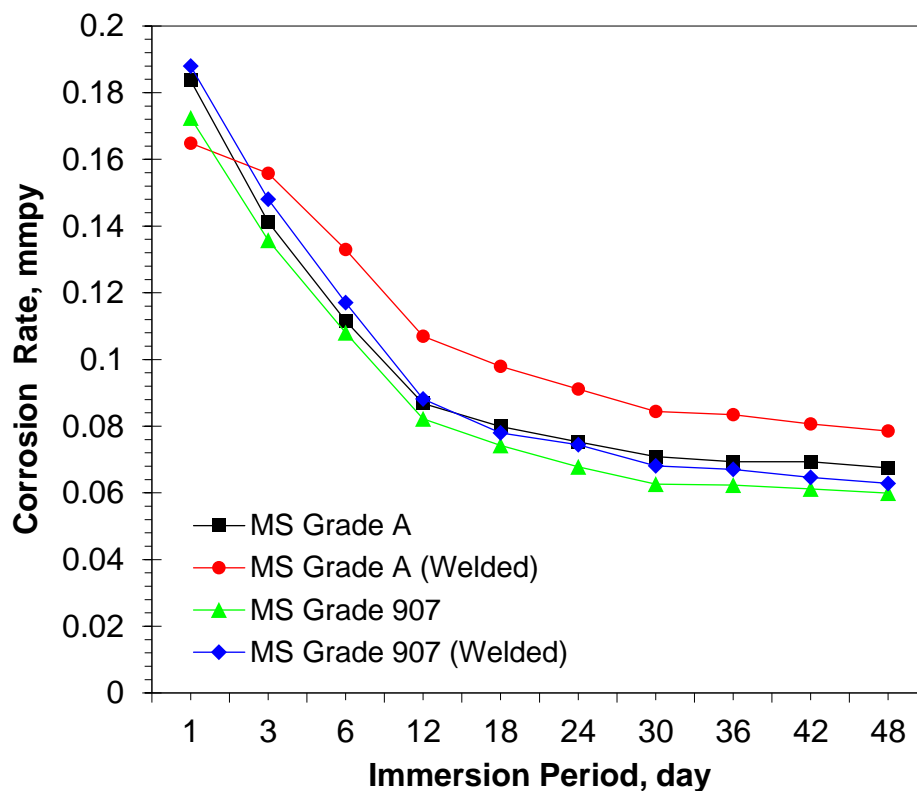
Figure 3.6: Corrosion rate vs Immersion period curve for Saint Martin Point Seawater

Figure 3.6 shows that in St. Martin's, the corrosion rates are notably different and more significant. As in previous cases, the initial corrosion rate was higher, followed by a decrease in the later stages. However, this reduction was again non-linear. Eventually, the rate stabilized, with no further decline towards the end of the test period. As a result, the testing period was not extended.

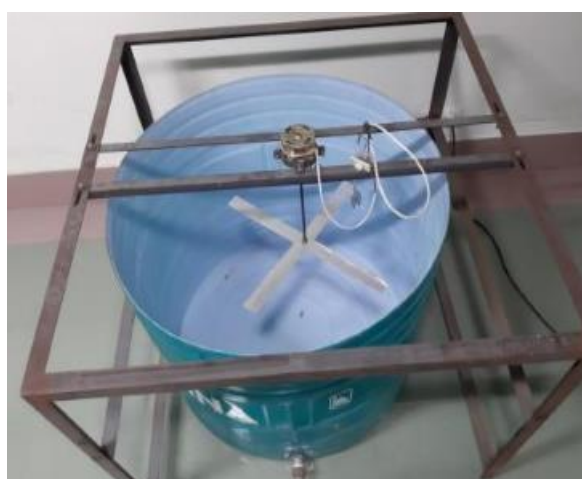
Figure 3.8: Experimental setup for the seawater dynamic lab test.

Based on the results of static experiment- dynamic test was carried out for the highest corrosive seawater. The setup shown in the Figure 3.8 was used to conduct the test. Relative velocity of 2 ms^{-1} was maintained while the propeller was rotating in the seawater with the hanging samples.

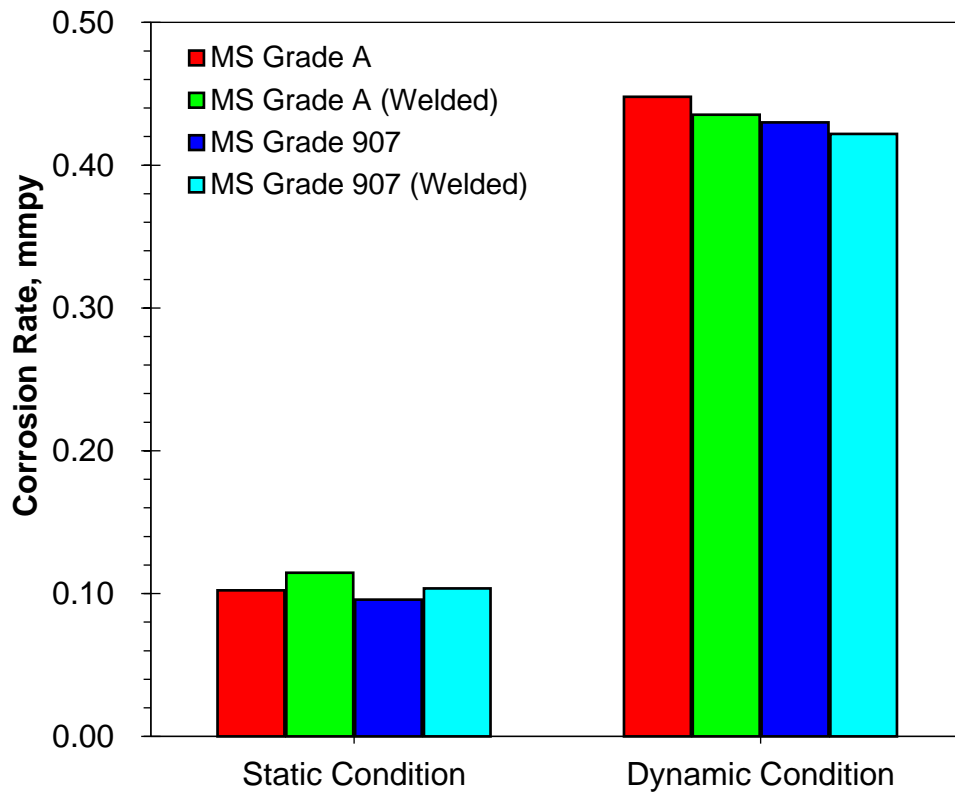
Figure 3.10: Comparison of Average Corrosion Rate of Static and Dynamic Condition of St Martins Anchorage Water

maintained to simulate conditions found in real marine situations, the corrosion rate was significantly higher compared to the static condition. This could be primarily due to the water velocity, which facilitated the faster transport of corrosive ions, such as chloride and sulfate, to the surface of the mild steel specimens. As a result, the increased ion flow might have led to a more aggressive corrosion process, continuously attacking the exposed steel.

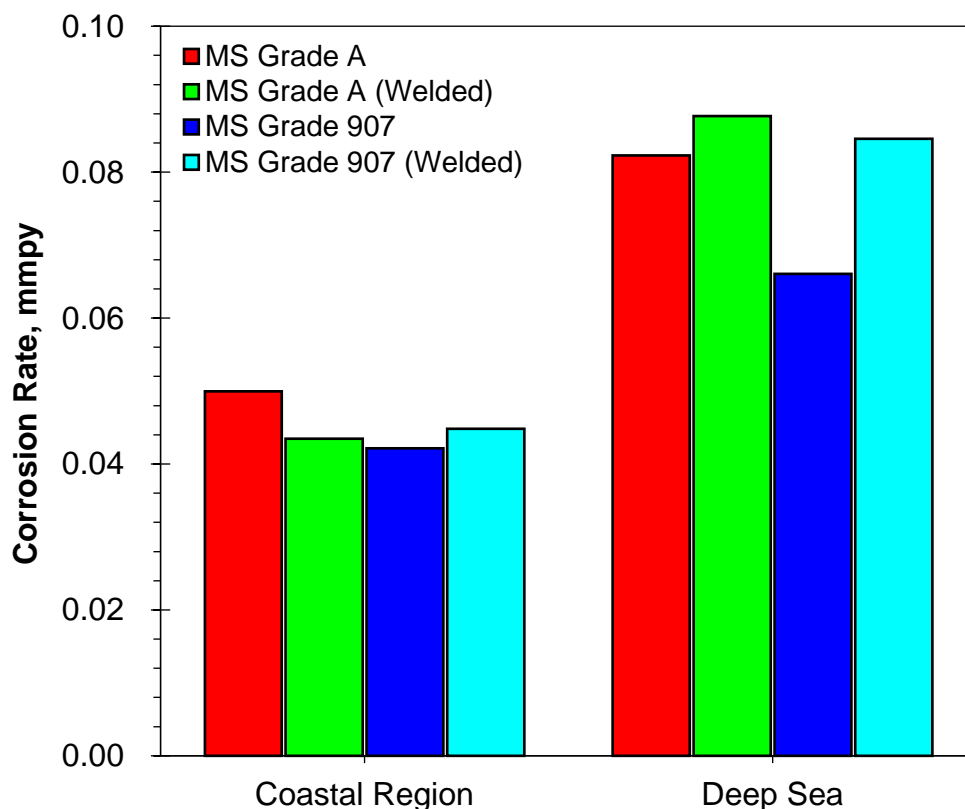
Figure 3.11: Comparison of Corrosion rates between deep sea and coastal region.

The results of the on-site tests carried out with the assistance of BN ships, shown in Figure 3.11 depicts that the average corrosion rate in the deep-sea region is 1.8 times higher than in the coastal region. From the chart, it was obtained that increment of corrosion rate in from coastal region to deep sea for-

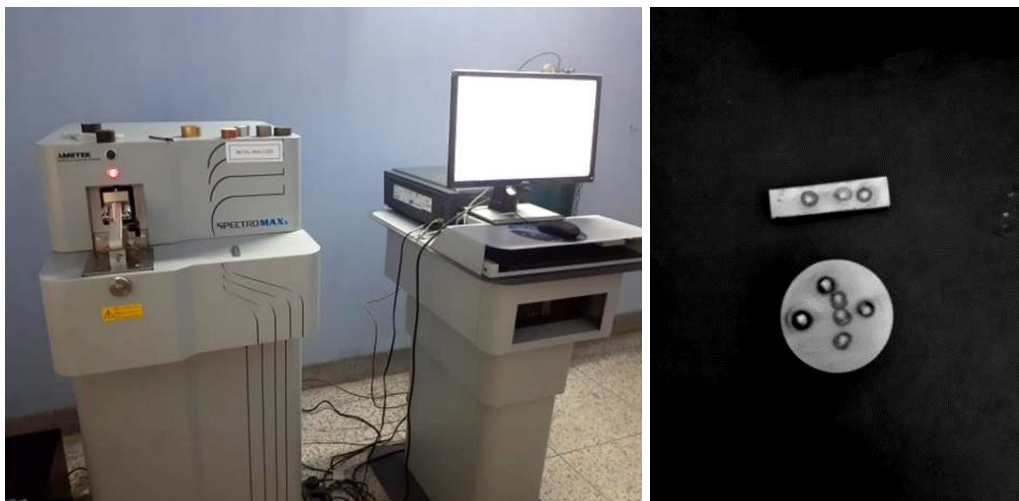
Figure 4.7: Experimental setup for chemical composition test

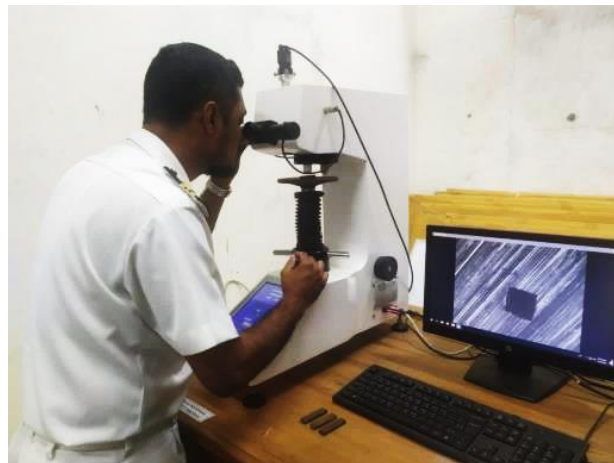
Figure 4.8: Micro-Vickers Hardness Testing

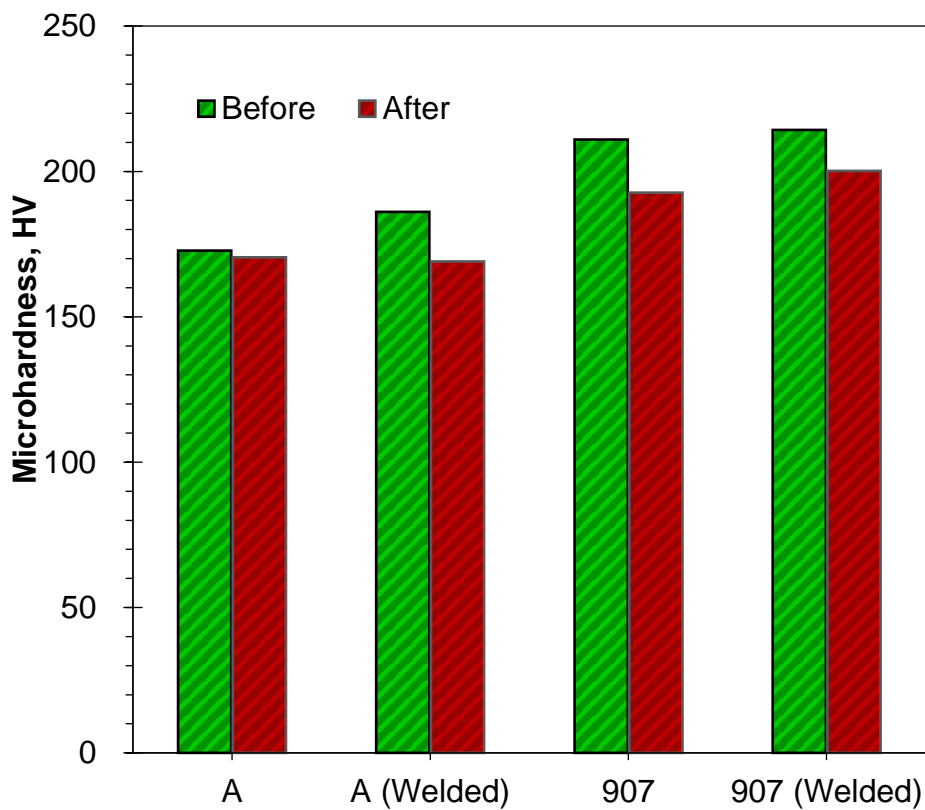
Figure 4.9 Viker's micro hardness for all four samples

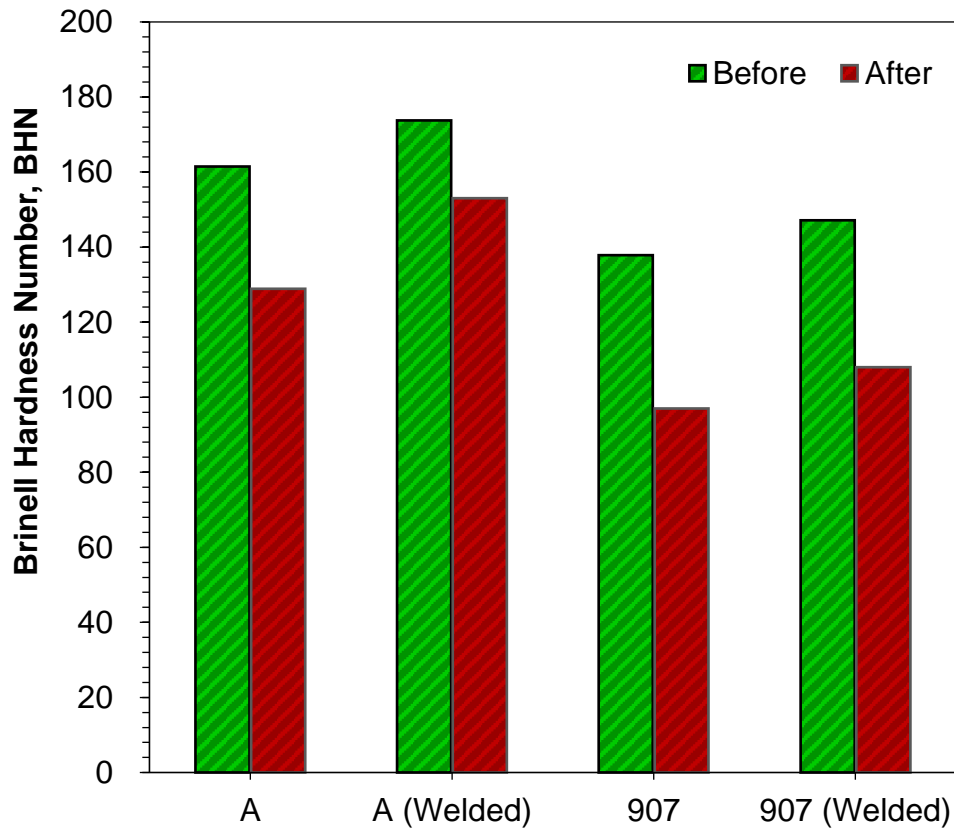
Figure 4.10 Brinell Hardness Number for all four samples

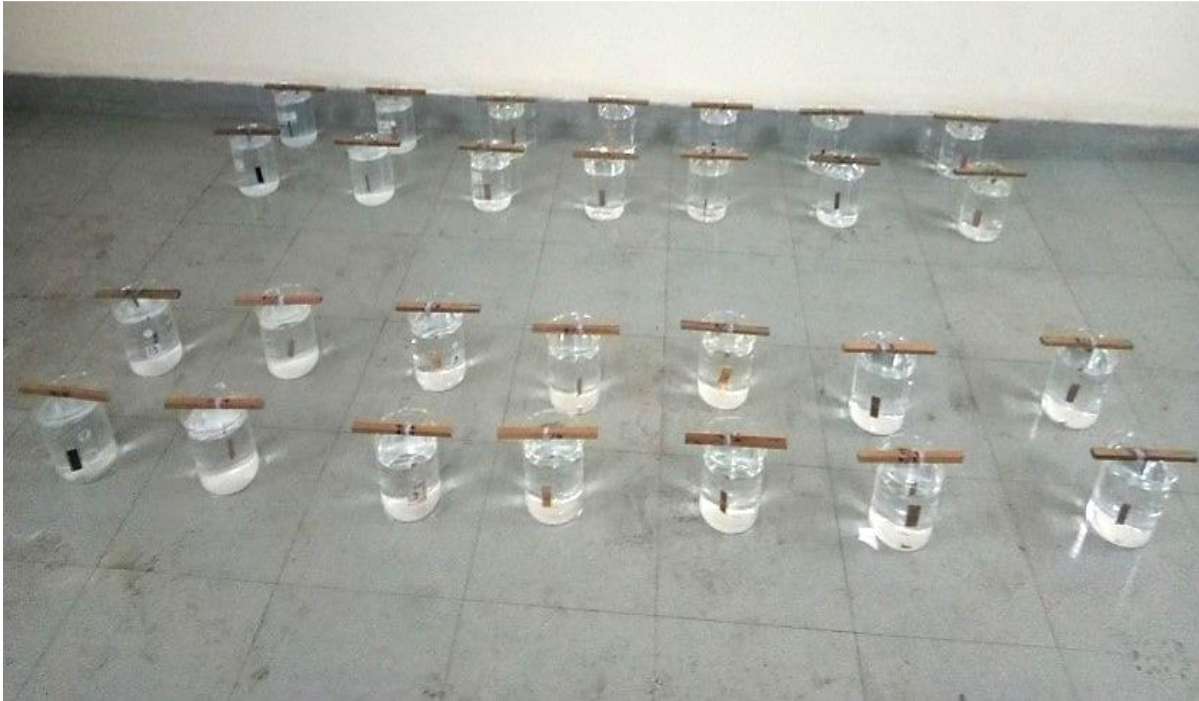
Figure 5.1: Experimental Setup for pH Varied Test

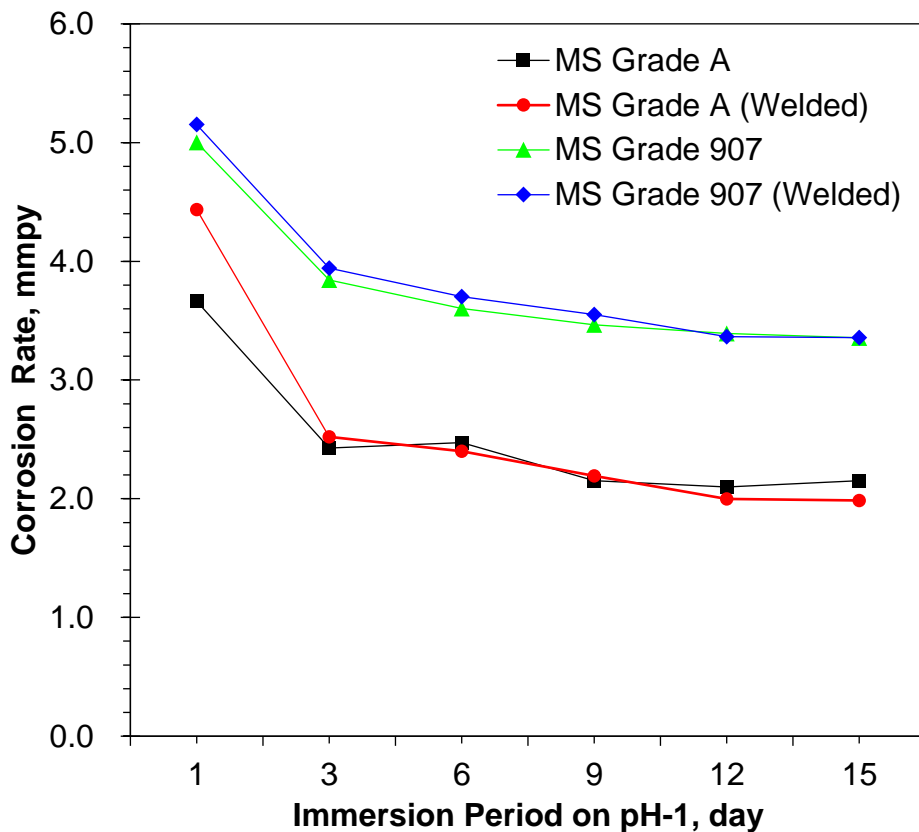
Figure 5.2: Corrosion rate vs Immersion period curve for pH-1 solution

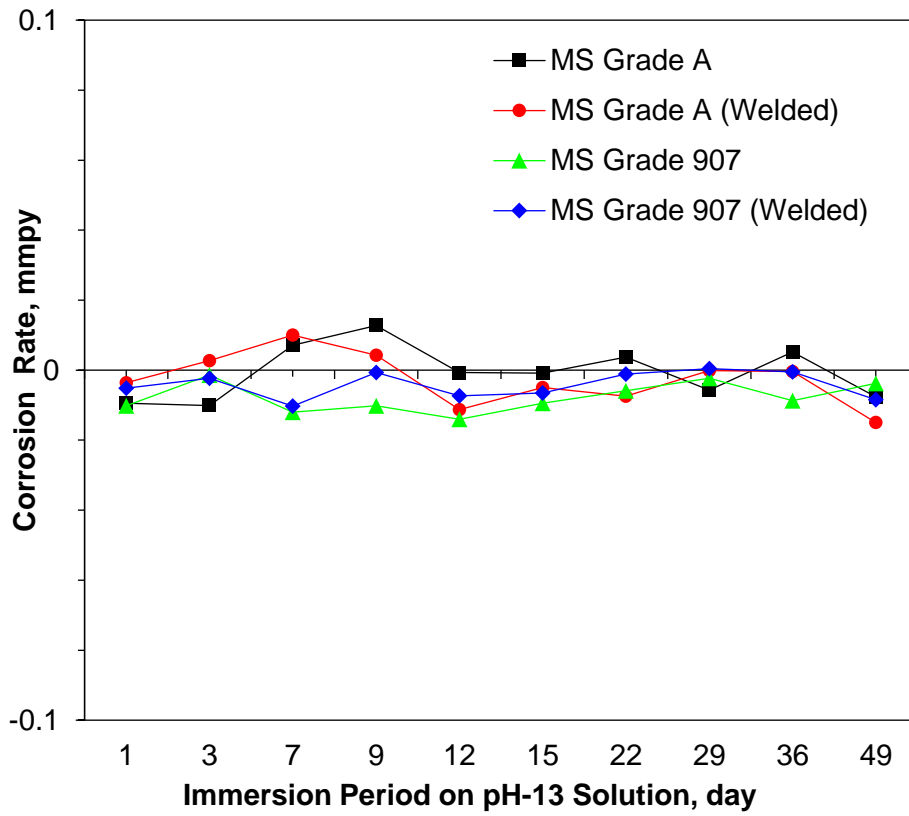
Figure 5.8: Corrosion Rate vs Immersion Period curve for pH-13 solution

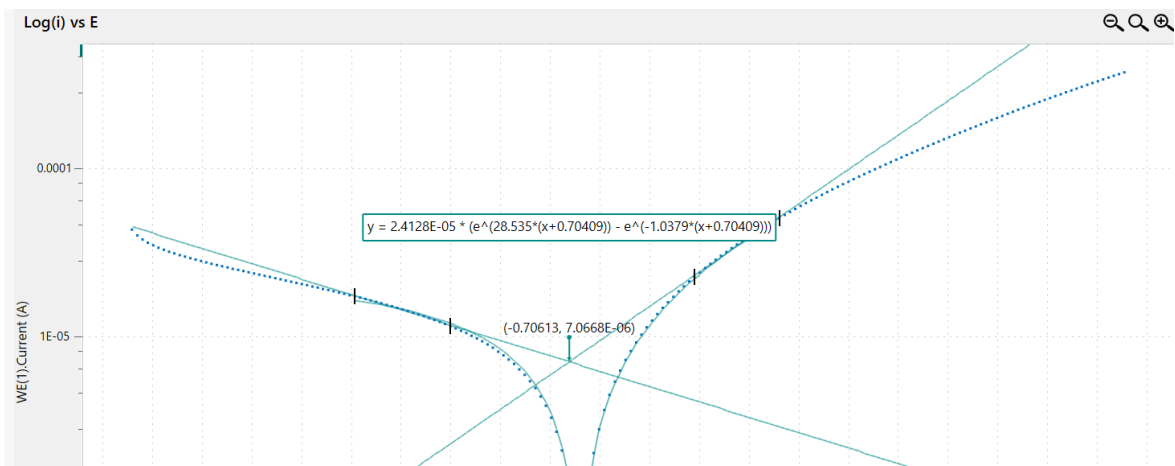
Figure 6.8: Tafel Plot of MS Grade 907 for 1 day
