# Through the Lens of Child-Friendly Space: Understanding the Physical Realities of Government Primary School in Dhaka

Zayed Kazi\* and Iqra Binte Zamil

Department of Architecture, Military Institute of Science and Technology, Dhaka, Bangladesh

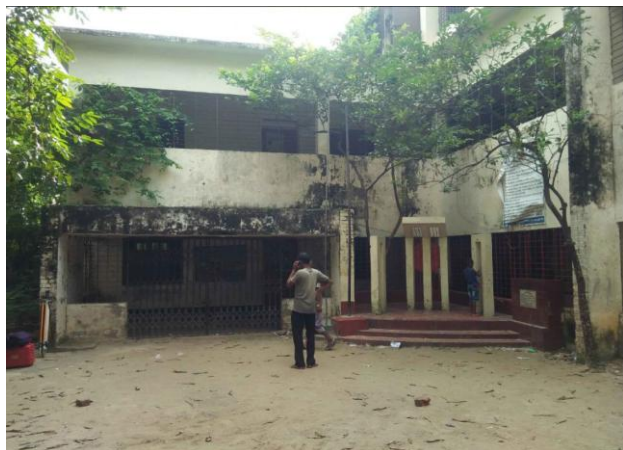
- **Indoor Environment:** This school meets the standard classroom size ( $\geq 1$  m<sup>2</sup> per student) and has a North-South orientation. However, the ventilation, with 12 m<sup>2</sup> of openings, is slightly below the standard, and it lacks major functional spaces, including medical, multipurpose, and storage rooms.
- **Outdoor Environment:** An outdoor playground is available. While access roads and corridors are present, universal accessibility is compromised. Safety features, such as designated boundaries and entrances, are in place.

- **WASH Facilities:** WASH conditions are very poor. Despite the availability of drinking water, sanitation is inadequate, and there are no handwashing facilities.
- **Summary:** Dhanmondi No. 1 Govt. primary school partially meets indoor size and outdoor criteria but severely fails in providing required functional spaces and maintaining WASH facilities.

**Figure 2:** View of the school from the playground

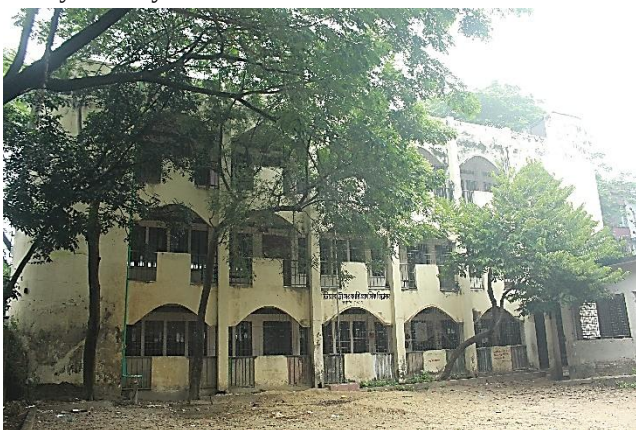
- **Indoor Environment:** The school lacks the standard classroom size for its student-to-class ratio (1:55). It ensures proper ventilation (14 m<sup>2</sup> of openings) and North-South orientation. Storage is available, but all other essential functional rooms are absent.
- **Outdoor Environment:** Outdoor facilities, including a shared playground and shaded areas under trees, are present. Access roads and corridors are available. Safety features such as specific boundaries or designated entrances are missing.
- **WASH Facilities:** WASH facilities are comparatively better. Drinking water, gender-specific toilets, and handwashing services are functional.
- **Summary:** Diabari Govt. primary school performs well in WASH and provides outdoor play/shaded areas, but struggles significantly with classroom size and safety/security features.

**Figure 3:** View of the school from the playground

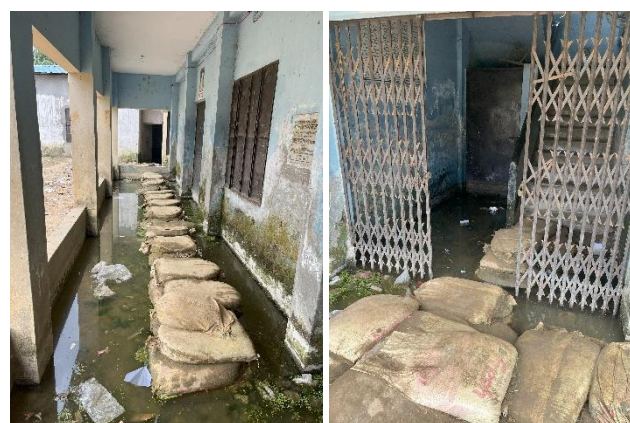
- **Indoor Environment:** The school meets the standard classroom size and has a North-South orientation. However, it has an inadequate opening size (12 m<sup>2</sup>) and lacks all indoor functional support rooms, including storage.
- **Outdoor Environment:** The school has a functional playground. However, it has very poor accessibility (no entry ramp; no access road) and lacks significant safety features.
- **WASH Facilities:** WASH facilities are in very poor condition. The facilities are inadequate, with no provision for drinking water, toilets, or handwashing.
- **Summary:** Chalaband Govt. primary school struggles across multiple indicators, including safety, accessibility, and severely deficient WASH facilities, though it meets the minimum classroom area standard. The school has experienced severe student dropout due to waterlogging and building issues.

**Figure 4:** Waterlogging condition at the entrance

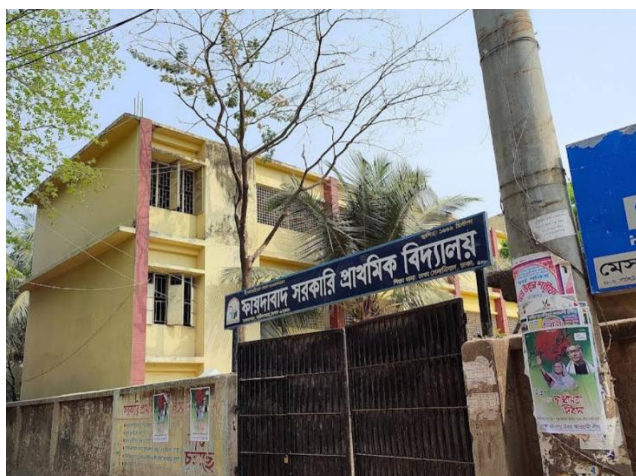
- **Outdoor Environment:** It has a shared open area. Access roads are limited, but safety measures are adequate with designated entrances and boundary walls.
- **WASH Facilities:** WASH facilities are inadequate. Drinking water is available, but there are no gender-designated toilets or handwashing stations.

**Figure 5:** View from the main entrance of the compound

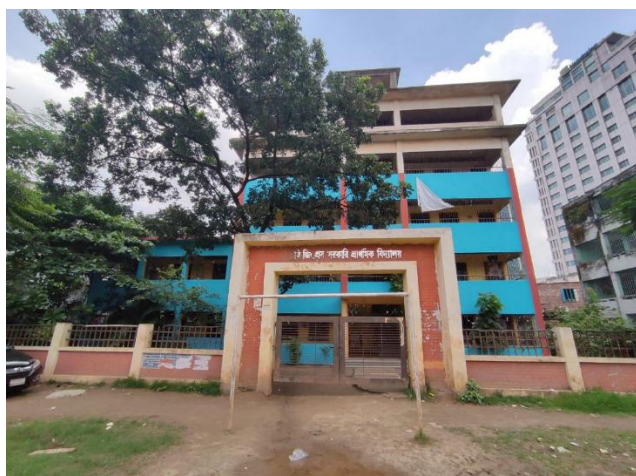
- **Summary:** BG Press Govt. Primary schools struggle with indoor functionality, outdoor play areas, and sanitation facilities, despite meeting the minimum classroom area standard.

**Figure 6:** View from the main entrance of the compound

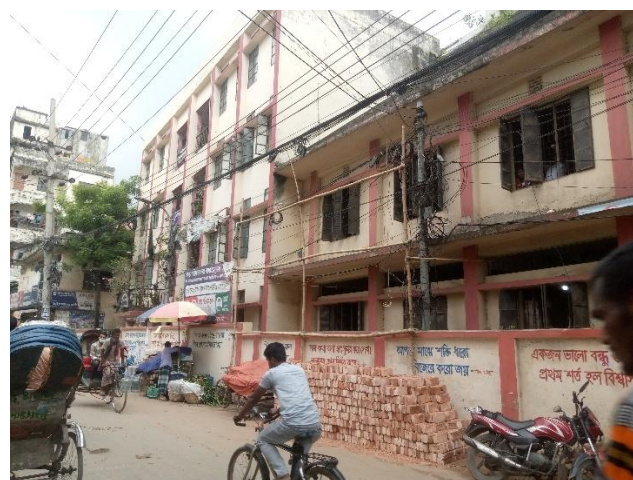
- **Indoor Environment:** Azimpur Adorsho Govt. primary school fails to meet student-classroom ratio standards (1:65 ratio) but maintains proper ventilation (12 m<sup>2</sup> of openings) and North-South orientation. It lacks the majority of indoor function spaces, including medical, multipurpose, and storage.
- **Outdoor Environment:** Outdoor facilities are very limited, with no open playground or shaded area. Accessibility

features, such as an entry ramp, are absent, but safety measures (boundaries and designated entrances) are adequate.

**Figure 7:** View from the street of the building

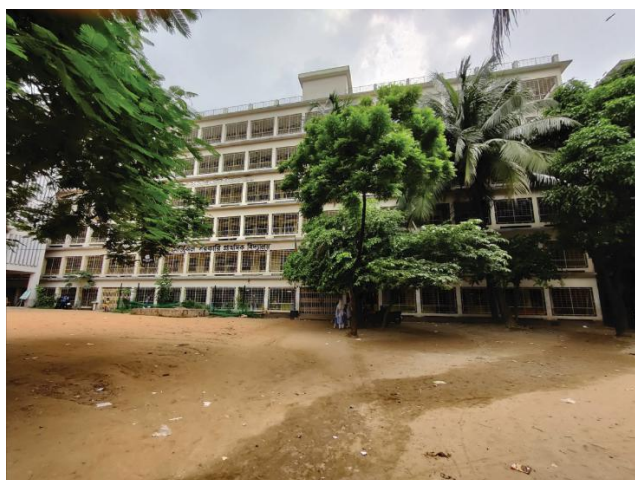
- **Indoor Environment:** The school lacks an adequate student-classroom ratio (1:50 ratio) but offers proper North-South orientation and ventilation (12 m<sup>2</sup> of openings). It has no provision for other functional rooms or storage.
- **Outdoor Environment:** Outdoor access facilities (access road and corridor) and safety infrastructure are satisfactory.

However, universal accessibility and an open playground are absent.

**Figure 8:** View from the playground of the building

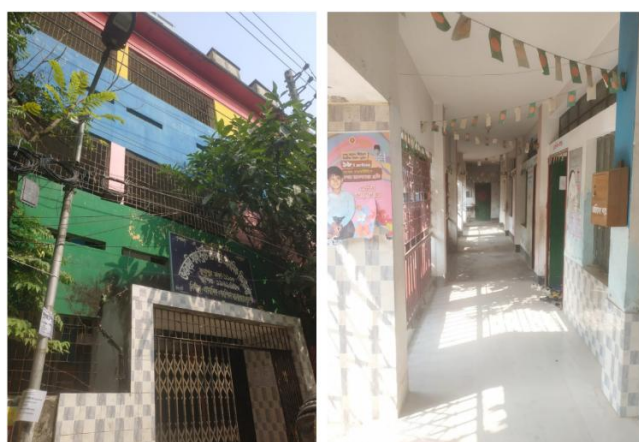
- **WASH Facilities:** WASH conditions are weak and rated as bad. While drinking water is available, there is no functional sanitation or handwashing provision.
- **Summary:** The Vojo Hori street Govt. primary school suffers from overcrowding, a lack of an outdoor play area, and poor sanitation facilities.

**Figure 9:** View from the entrance and corridor

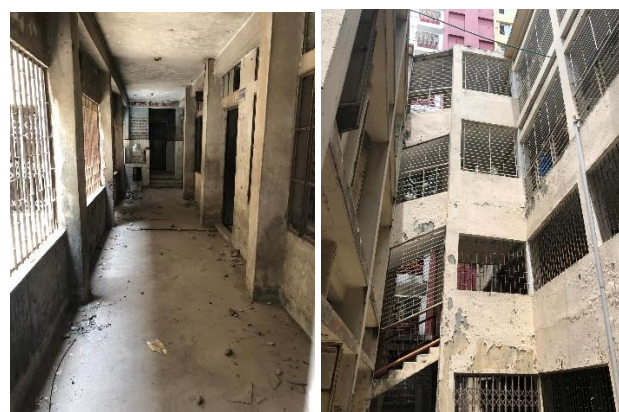
- **Indoor Environment:** Manik Nagar Govt. primary school struggles with classrooms, with the highest student-to-class ratio (1:105) among the surveyed schools, and fails the size standard. Though it has a North-South orientation, 12 m<sup>2</sup> of openings, and provides storage, all other functional spaces are absent.
- **Outdoor Environment:** The school lacks an open playground and ramp. Access roads and corridors are satisfactory, and safety features are adequate.
- **WASH Facilities:** Sanitation facilities are rated as very poor. Drinking water is available, but toilet and handwashing facilities are insufficient.

- **Summary:** This school is overcrowded, has poor building conditions, lacks a playground, and has critically poor sanitation facilities.

**Figure 10:** Building and settling condition

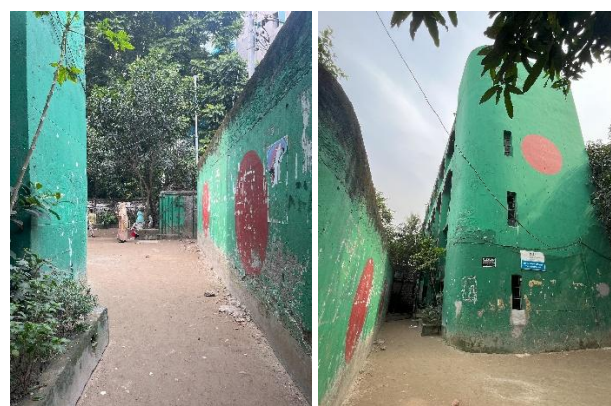
- **Indoor Environment:** The school does not meet classroom size standards (1:50 ratio). It has a North-South orientation, 12 m<sup>2</sup> of openings, and includes storage, but lacks functional rooms.
- **Outdoor Environment:** There is no open playground or shaded area. Accessibility is severely limited by a very narrow 1.5m access road. Safety provisions (boundary and designated entrance) are not met.
- **WASH Facilities:** WASH facilities are rated as bad. While drinking water is available, sanitation and handwashing facilities are severely inadequate.
- **Summary:** Agargaon struggles across most CFS criteria, especially in classroom adequacy, accessibility (narrow road), safety, and hygiene

**Figure 11:** Narrow access road towards school
