SEISMIC PERFORMANCE EVALUATION OF A FIRE-DAMAGED HIGH-RISE BUILDING

M.Sc. ENGINEERING THESIS

**DEPARTMENT OF CIVIL ENGINEERING
MILITARY INSTITUTE OF SCIENCE AND TECHNOLOGY
DHAKA, BANGLADESH**

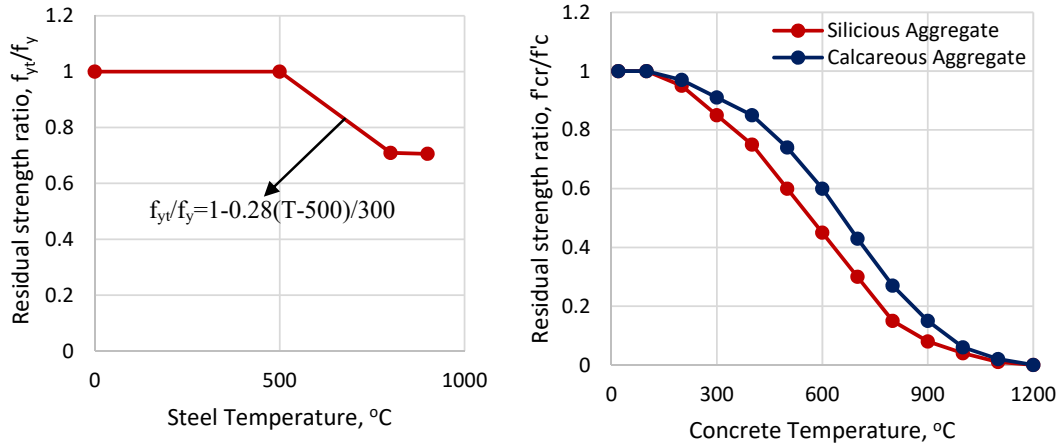
Fig 2.1: Variation of residual strength of rebar and concrete as a function of maximum temperature (EN, 2004).

The effect of temperature on the reduction of compressive strength of concrete is associated with the chemical and physical modification and configuration of concrete. It is possible to assess the temperature-induced loss of strength in steel (rebars) and concrete layers by knowing the temperatures in those layers. Typically, after cooling, reinforcing steel regains the majority of its strength and stiffness. Nevertheless, the residual strength of steel decreases as the maximum temperature in rebars increases, especially when that temperature approaches 500°C. According to temperature-residual strength test results published by some researcher (Neves, Rodrigues and Loureiro 1996) that, the loss of strength in reinforcing steel is anticipated to follow in the suggested design method. Fig 2.1 depicts the change in steel and concrete residual strength as a function of maximum temperature.

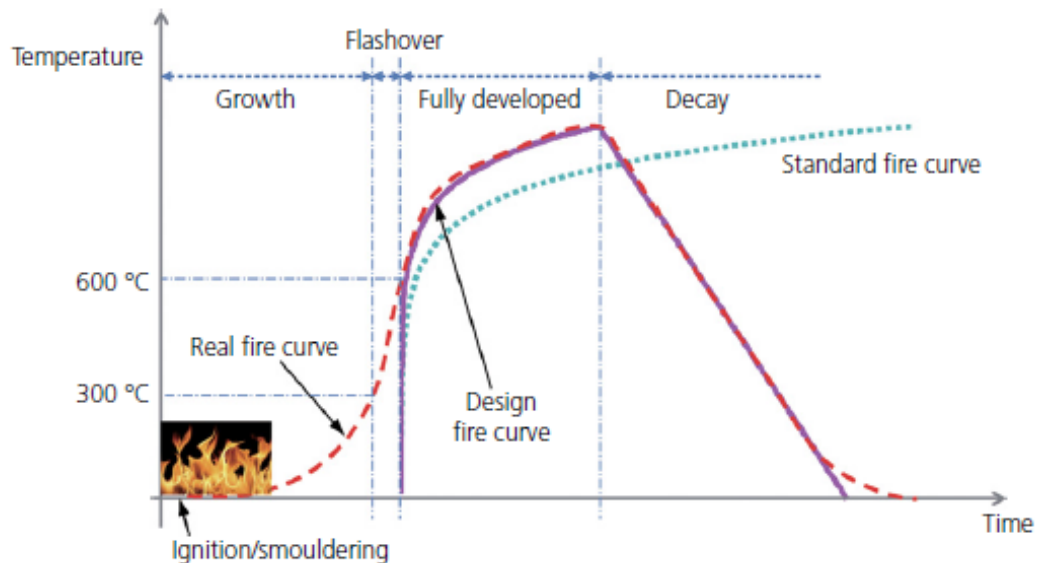
Fig 2.2: Temperature development of a real fire and a standard fire (Bisby and Stratford, 2013).

flashover occurs and the fire enters the fully developed stage, when the temperature may exceed 1000°C.

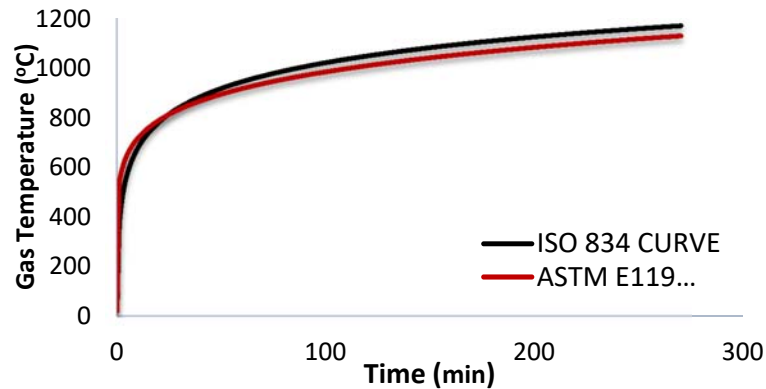
Fig 2.3: Temperature time curves.

Gas temperatures can be estimated using a design fire. A nominal fire or a natural fire can be selected. A nominal fire is represented by a standard curve (Fig 2.3) of uniform gas temperature with time (ISO 834, 1999a). It is independent of fuel and ventilation conditions and continues with time without decaying. A natural fire depends on fuel, geometry, and ventilation conditions, and it decays following the stages of a typical fire, as described above. Simplified models can be used to predict gas temperature, such as one-zone models, two-zone models, and computational fluid dynamics. Nominal fires are often used for designing purposes.

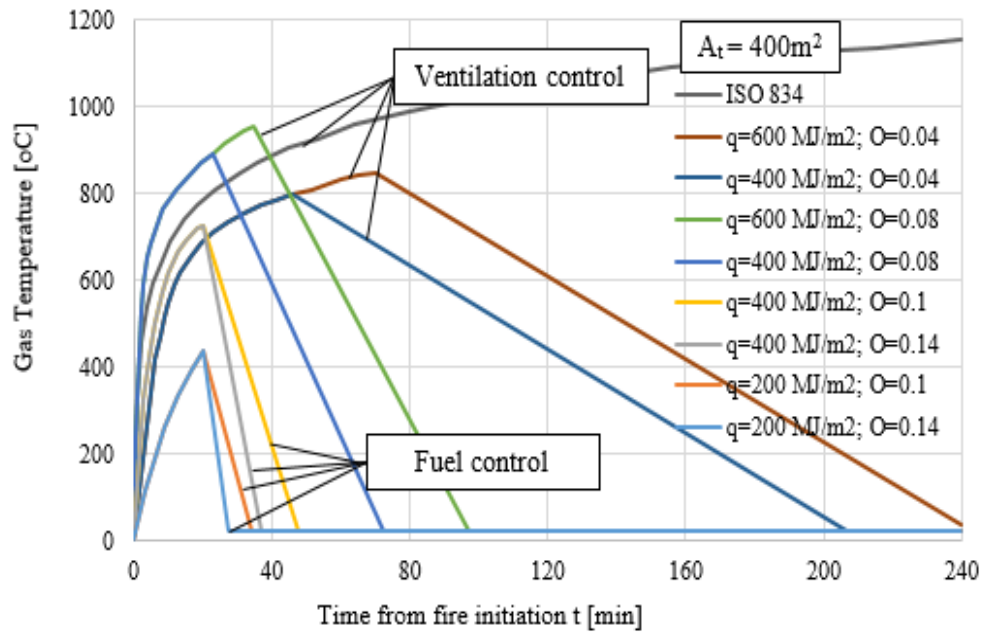
Fig 2.4: Temperature time curves for various opening factors and fire load (Van Coile, 2015).

The opening factor method uses information on fire load and ventilation openings, as shown in Fig 2.4. The Euro code parametric fire curves approximate the opening factor method using an equation with parameters regarding geometry, fire load, ventilation, and thermal properties of surrounding fire compartment surfaces.

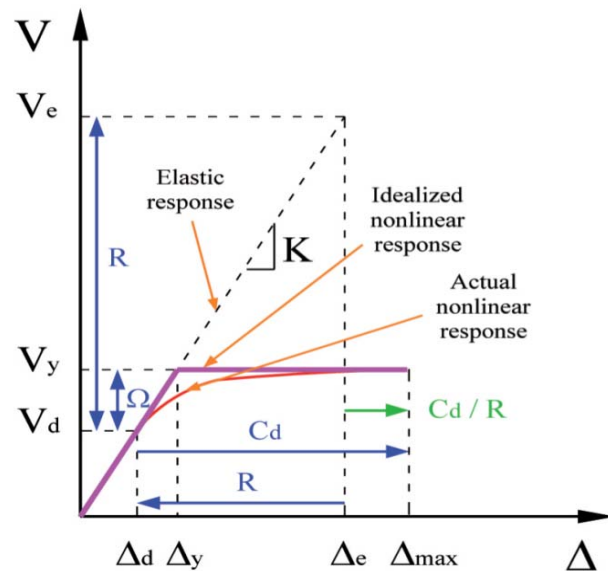
Fig 2.5: Assumed force-deformation relationship (Varela, Tanner and Klingner, 2004).

The seismic design philosophy is predicated on permitting damage at certain areas in the structural elements, such as at beam ends and the bottom of the lowest storey columns in lateral force resisting systems. This is done for economic reasons. The response modification factor/force reduction factor, denoted by R , is used to implement this design concept in similar linear static force and code-based response spectrum analyses (FEMA-450, 2003; and IBC, 2012b). In the event of a seismic event, this factor regulates the seismic reaction of the structure. The force-deformation connection when the seismic design philosophy is used on a structure is shown Fig 2.5.

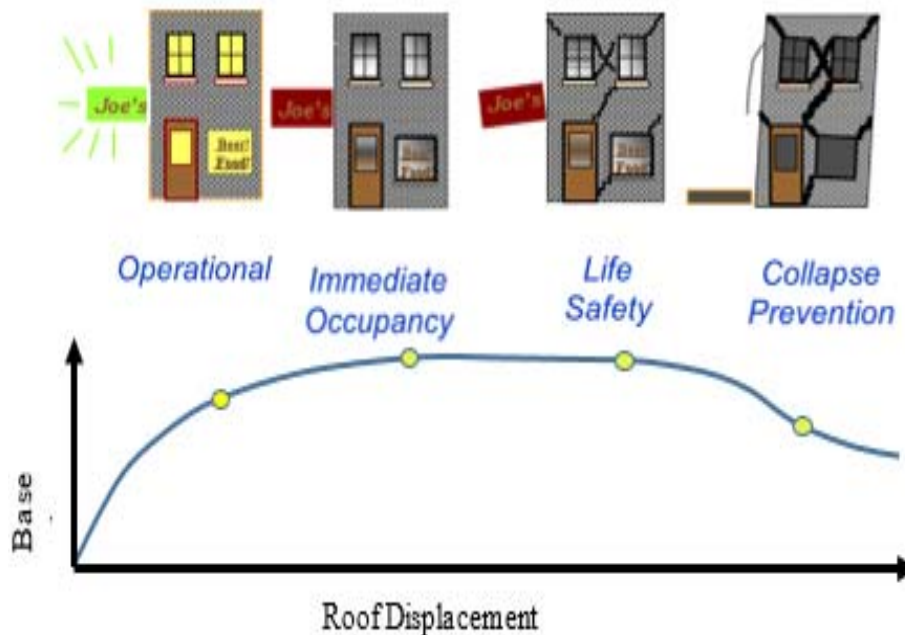
Fig 2.6: Illustration of performance level (Pekelnicky et al., 2012).

Performance Level	Description
Operational (O)	Negligible impact on building. Building can be occupied. No repair work required.
Immediate Occupancy (IO)	Building is safe to occupy but will need little repair work.
Life Safety (LS)	Building is safe during the event but possibly not afterward. Building can be occupied after subsequent repair.
Collapse Prevention (CP)	Building is on the verge of collapse, probable total loss. Building is far beyond the economically feasible repair.

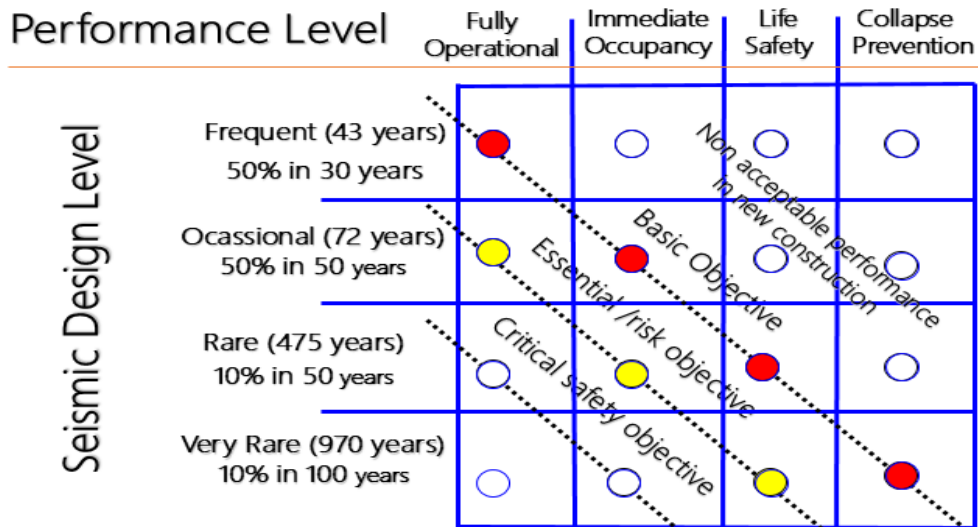
Fig 2.7: Structural performance criteria (Pekelnicky et al., 2012).

Some researcher has outlined four analytical methods for analysis and design purposes known as Linear Static Procedure (LSP), Linear Dynamic procedure (LDP), Nonlinear Static Procedure (NSP) and Nonlinear Dynamic Procedure (NDP). In the present study, only nonlinear time history analysis is done for the damage assessment of a case study building. Performance criteria of building for different seismic level has been shown in Fig 2.7.

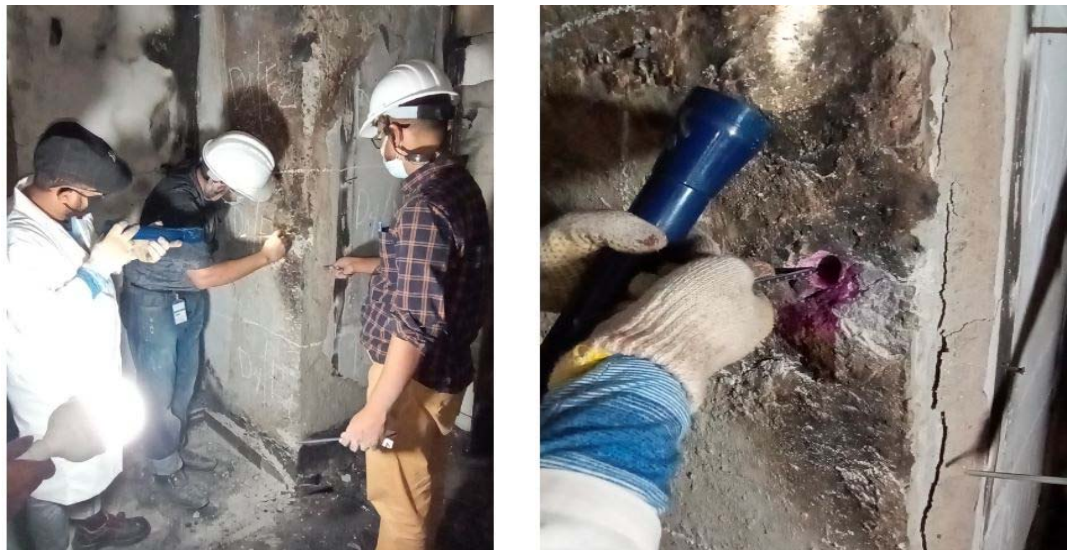
a) Surface preparation for indicator spray b) Measurement of carbonation depth

Carbonation depth tests were conducted on-site at various locations. A total of 29 carbonation tests were done on the seventh-floor roof, whereas 29 and 23 tests were done on the eighth and ninth floors, respectively.

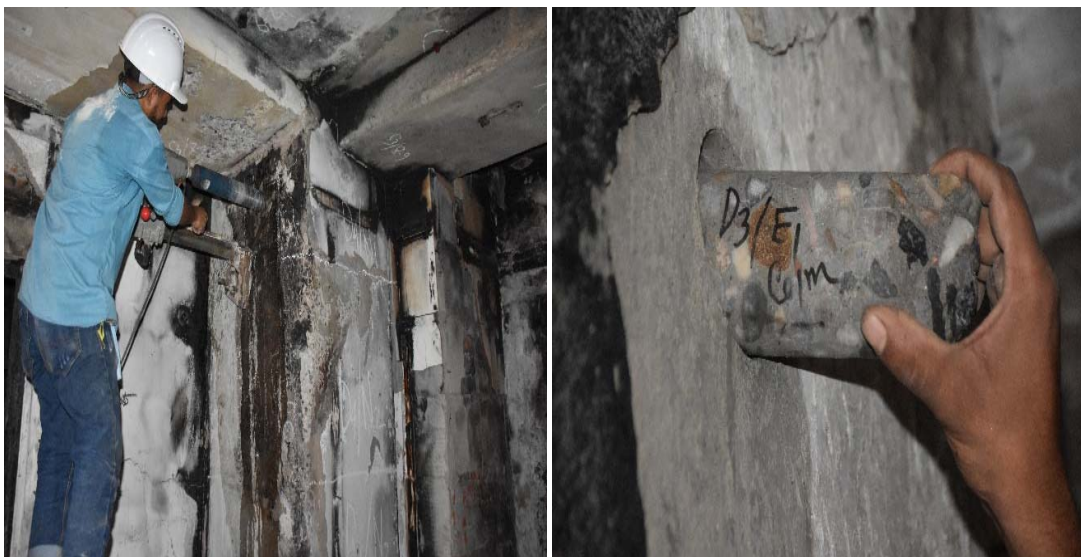
a) Collection of concrete core samples

The collection point for core samples was selected after a visual inspection of the fire-damaged structures. The fire-affected and unaffected column sections were selected for core collection, considering the minimum disturbance of the existing structure. Since the column and shear wall are the key structural components of the building's stability, 23 core samples were collected from the seventh, eighth, and ninth-floor columns and shear walls.

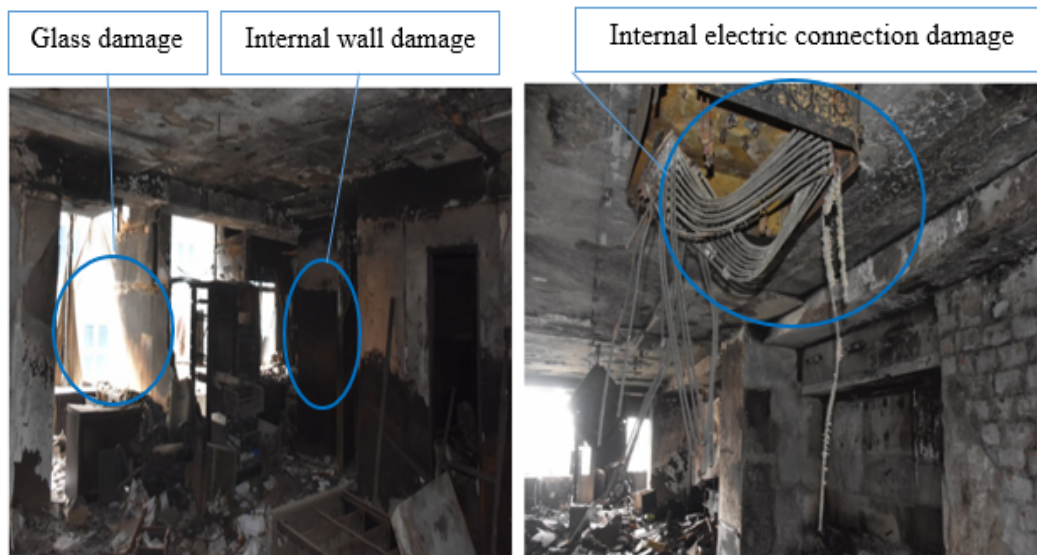
a) Damage to the internal wall and peripheral glass partition on the 7th Floor (Grid-D/3,4)

b) Damage to the internal electric connection on the 7th Floor (Grid-A, B, C/1)

The lift core and stairs have become a well of smoke during the fire. The external and internal fire-damaged views have been shown in Fig 4.3 & Fig 4.4, respectively. The glass of the periphery wall was heated, cracked, and gone to pieces for fire intensity. Fig 4.4 highlighted the condition of the building even before cleaning burned debris inside the compartments, the development of cracks, and burning of the structural and non-structural components.

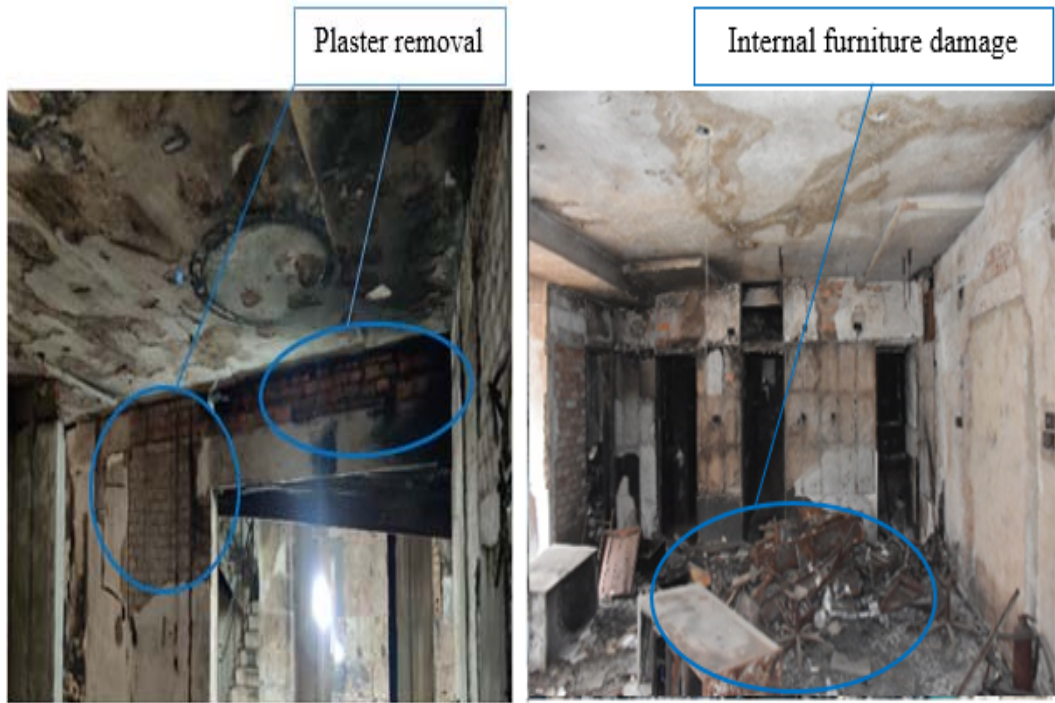
c) Plaster removal in front of the stair on the 8th Floor (Grid-B,C/3,4)

d) Damage to internal furniture in front of the toilet zone on the 8th Floor (Grid-C, D/4)

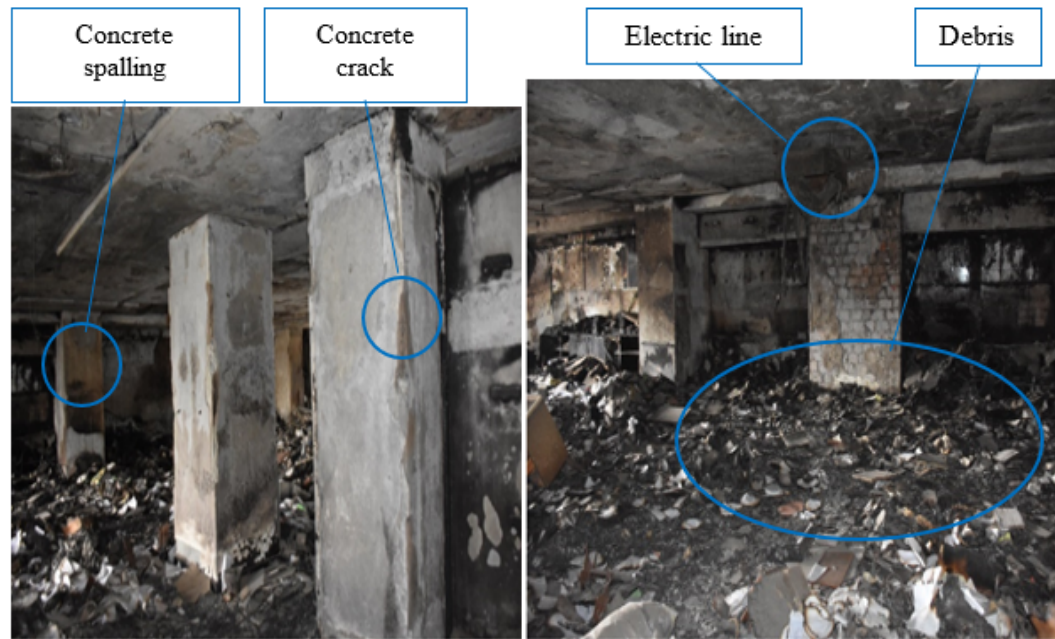
e) Some concrete cracking and spalling on the 9th Floor (Grid-B, C, D/2)

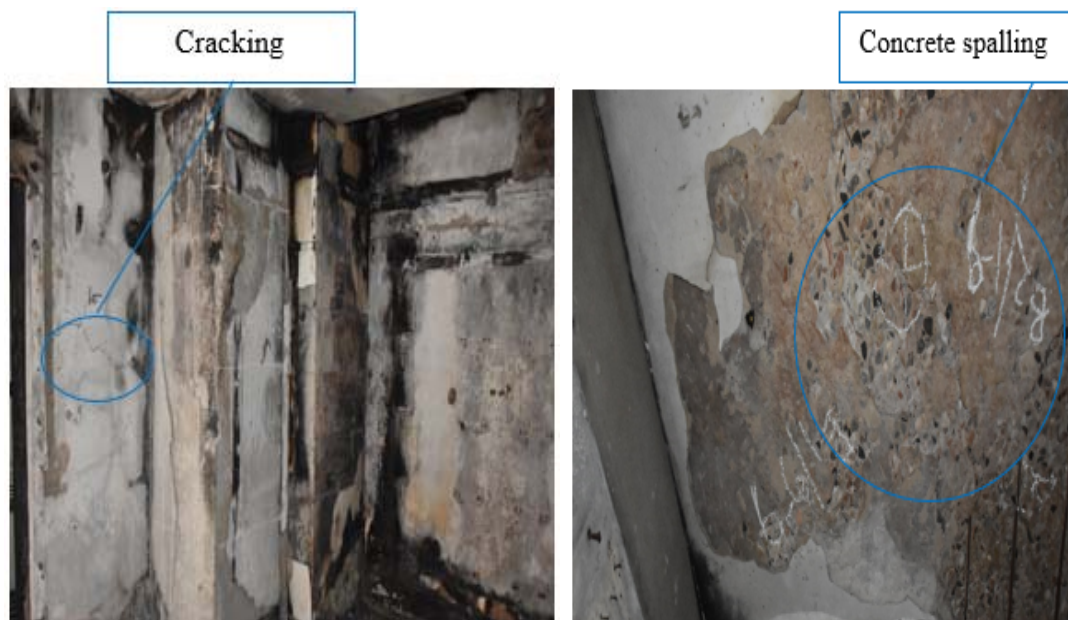
a) The column on the 7th floor (Grid: D/3)

b) Slab at 7th floor roof (Grid: B1/9-9, B2/1-9)

Fig 4.5: Some pictorial evidence of structural concrete damage.

Damages caused by the fire on different structural and non-structural components were similar. The amount and patterns of damage depend on the heating time, fire load, lining materials of the surface, ventilation type, loading conditions, evacuation plan, and active and passive fire resistance systems. Damage assessments of structural components such as columns, shear walls, beams, and floors are critically important for a structure's stability. However, the degradation of the strength and integrity of concrete and the reduction of the cross-sectional area due to spalling at the elevated temperature result in diminishing both vertical and lateral load-bearing capacity.

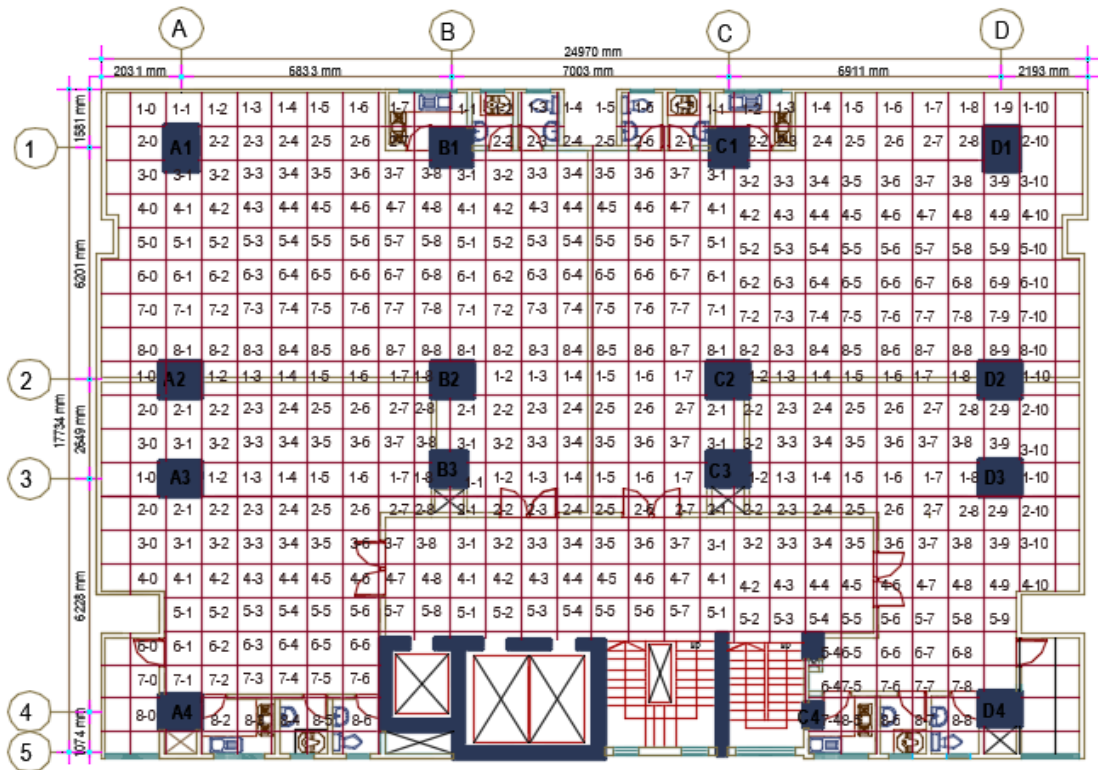
Fig 4.6: Typical floor subdivided into 900 mm X 900 mm grid.

To determine the intensity of fire at different zones of the floor, the entire fire-burnt area of the building structure, particularly the seventh to the ninth-floor roof, has been classified into six types based on the intensity of the damage. The column, beam & roof slab of the seventh, eighth and ninth floor has been subdivided into finite sizes of 900mm X 900mm (Fig 4.6) grid. The subdivided grid system helps the stakeholders understand the damages' location (Fig 4.7) and their corresponding intensity. As a result, post-fire potential retrofitting or strengthening plans can be developed accordingly.

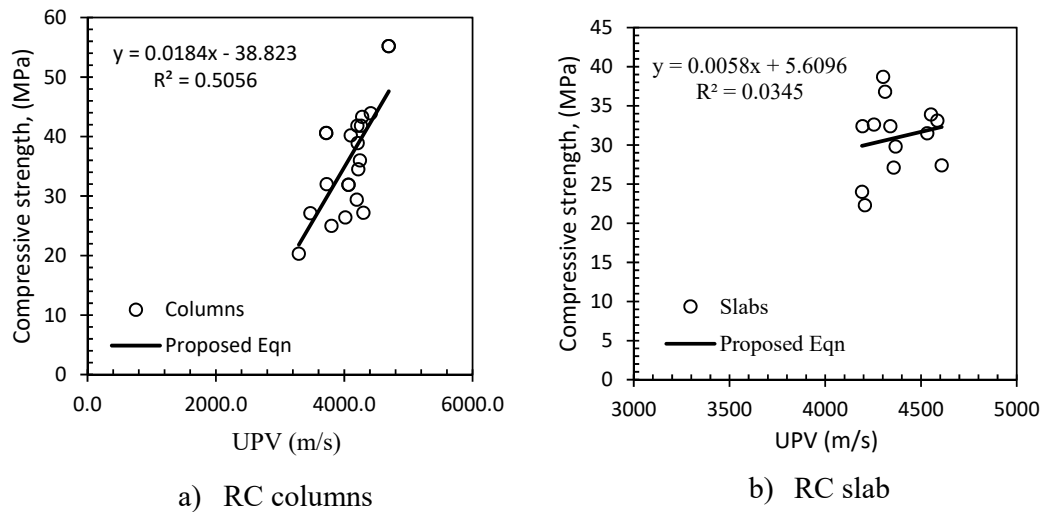
Fig 4.9: Compressive strength vs. ultrasonic pulse velocity plot for RC columns and slab.

Based on the concrete compressive strength and UPV test data measured from the concrete core samples of the column and slab section, a regression equation has been proposed, as shown in Fig 4.9. The proposed equation may help predict the compressive strength of existing column and slab sections without conducting further harmful drilling into the column. The result shows a linear correlation between the core strength and UPV test data. The coefficient of determination is 0.5056 for the column and 0.0345 for the slab, which is reasonably good for the compressive strength of these fire-burnt concrete cores.

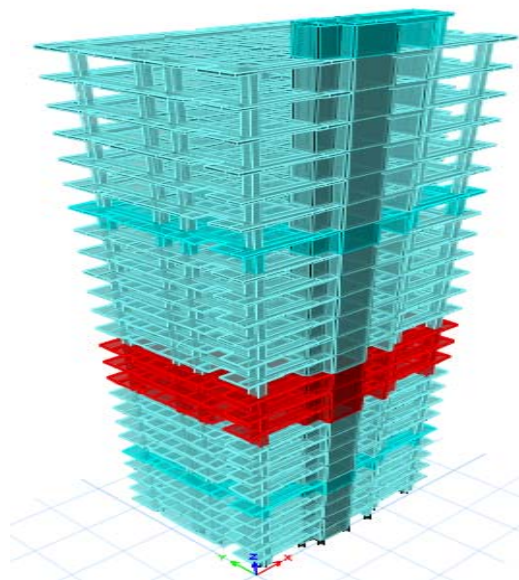
Fig 4.10: 3D View of FR Tower (Fire Affected 7th, 8th & 9th Floor).

Fire is an unanticipated phenomenon that causes severe loss of lives and property everywhere in the world. Generally, fires occur either by man-made accidents or natural hazards i.e., post-seismic fire events, volcanic incidents, etc. Based on the temp-time relationship, fire may be categorized into several types: International Standards Organization (ISO) fire, hydrocarbon fire, natural fire, British Standards (BS) fire, and parametric fire. The major issue of concern in fire events is the degradation of material strength for both concrete and rebar yield strength, tensile strength, elongation, and modulus of elasticity. Fire of the studied building has affected the building at 7th to 9th floor roof which has been shown the Fig 4.10.

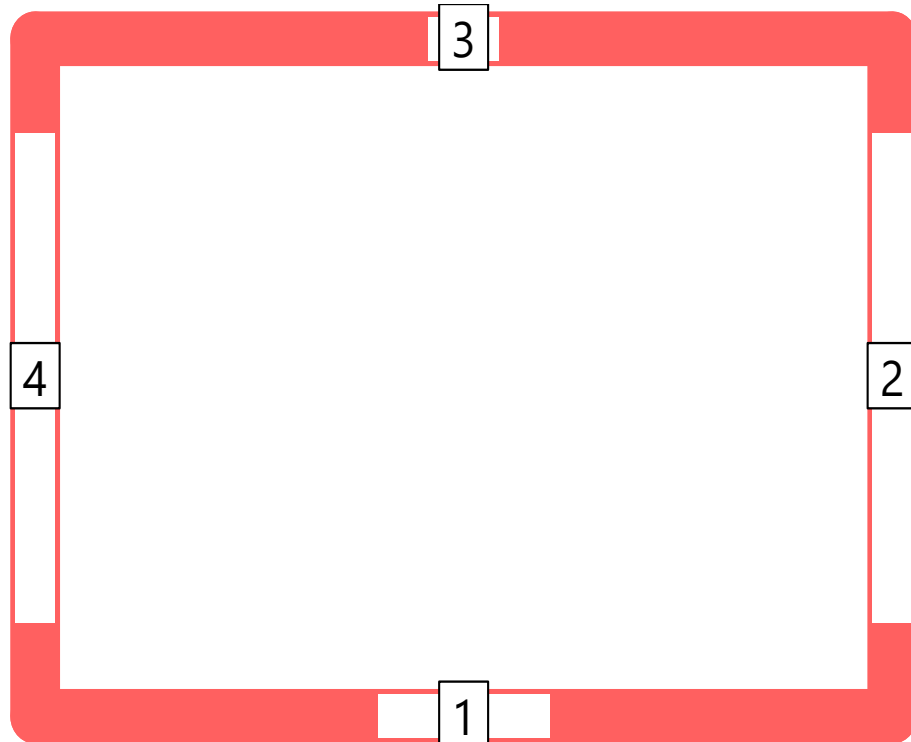
Fig 4.11: Fire zone walls.

The fire zone (Fig 4.11) has been used to calculate (Table 4-10 to Table 4-13) the parametric gas temperature and a fire curve has been developed (Fig 4.12) according to Eurocode (En, 2002) using FIN EC software.

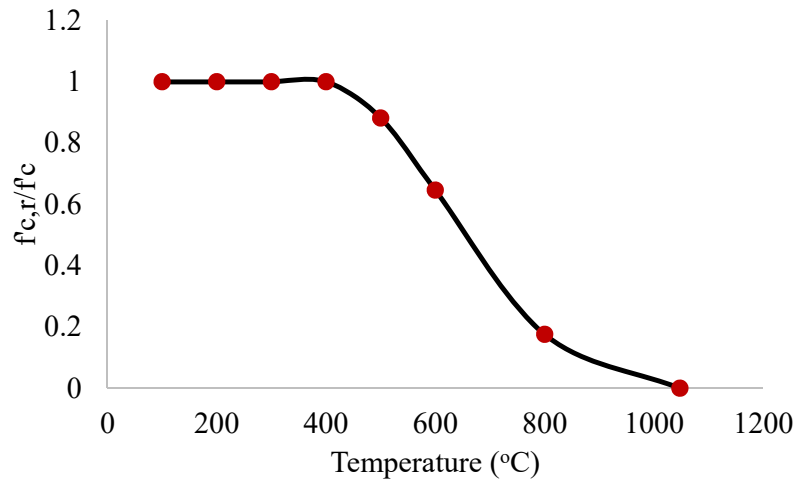
Fig 4.17: Concrete compressive strength reduction with temperature.

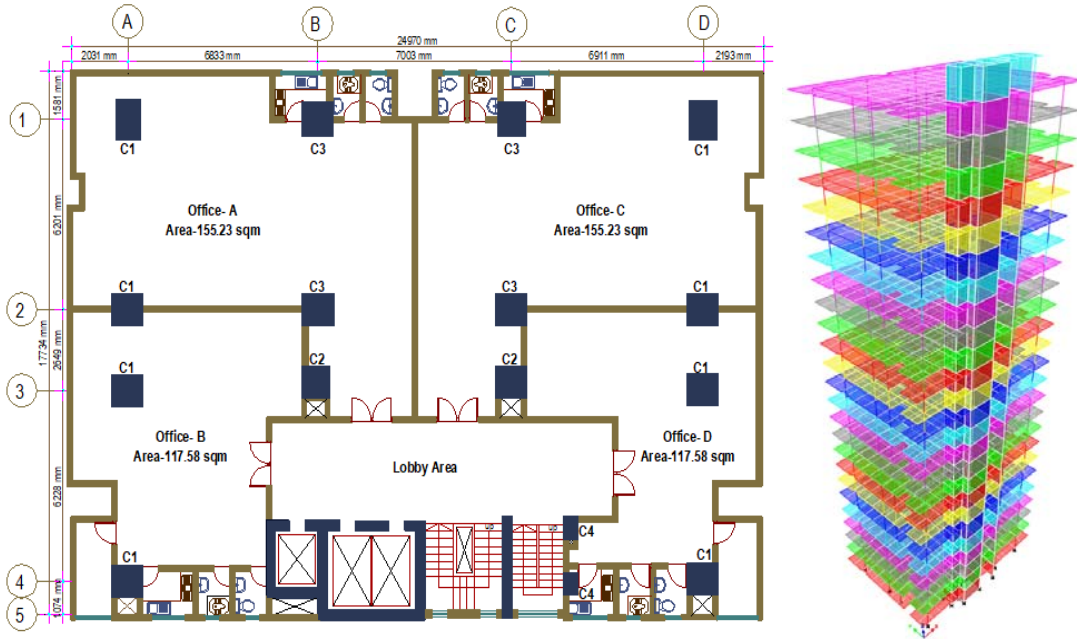
Fig 5.1: Typical floor plan & 3D view of the building.

to the roof. The typical cross-sections of the beams and columns are shown in Fig 5.2. There are four types of columns, both square and rectangular, and the cross-sectional dimensions of columns C1, C2, C3, and C4 are 975 x 1225 mm, 1075 x 1075 mm, 1200 x 1200 mm, and 375 x 1050 mm, respectively, at the ground floor.

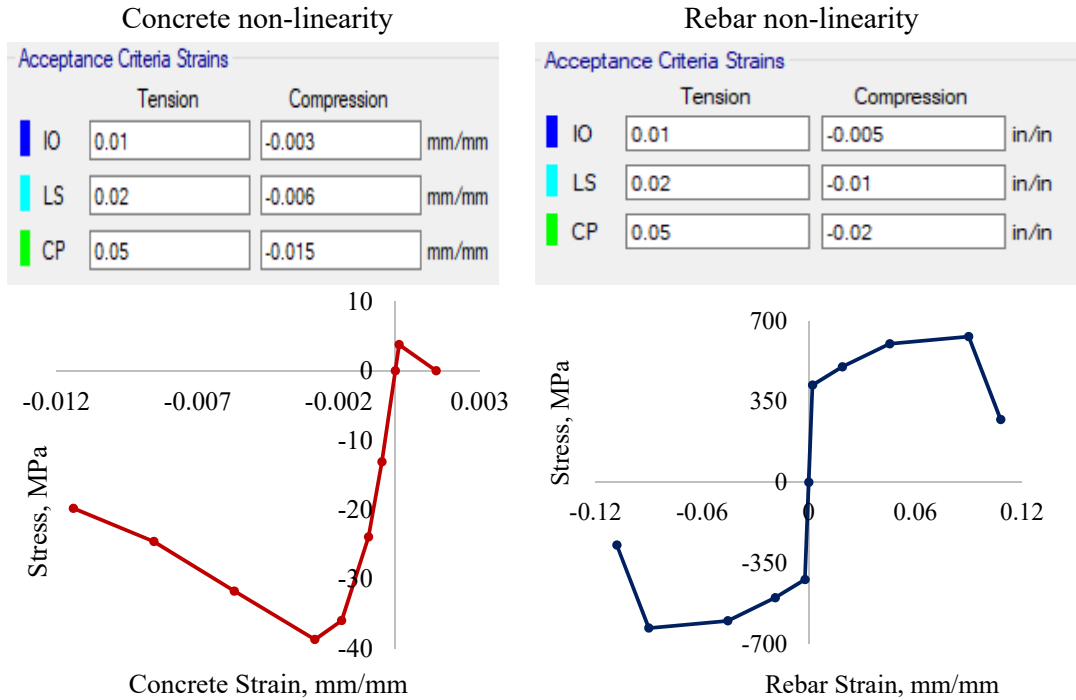
Fig 5.3: Material nonlinearity.

The non-linear properties of concrete and rebar are shown in Fig 5.3. The meander model is considered for concrete, whereas the kinematic hardening model is considered for hysteretic responses of the rebar.

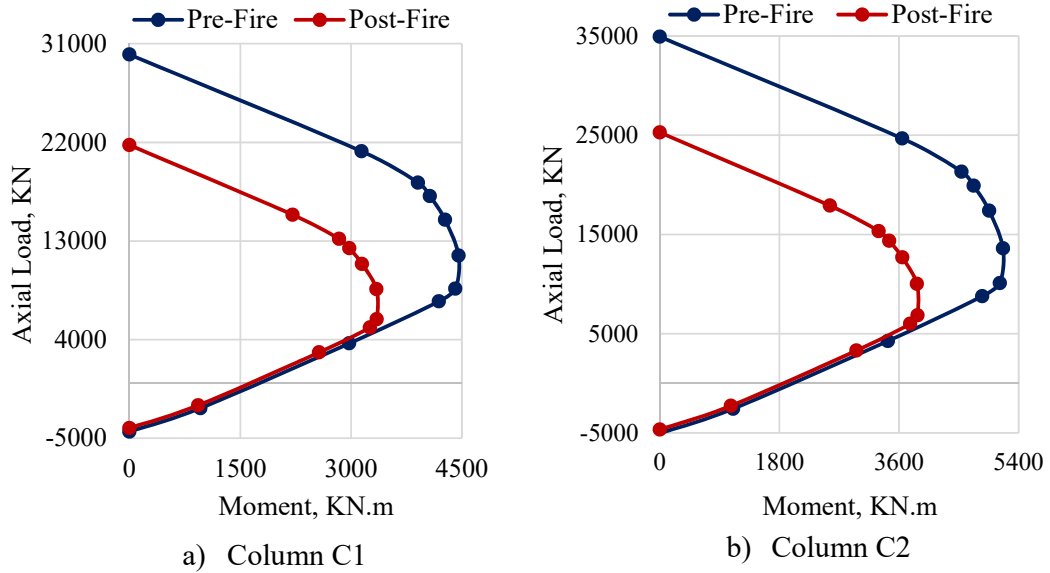
Fig 5.8: Column Interaction Diagram.

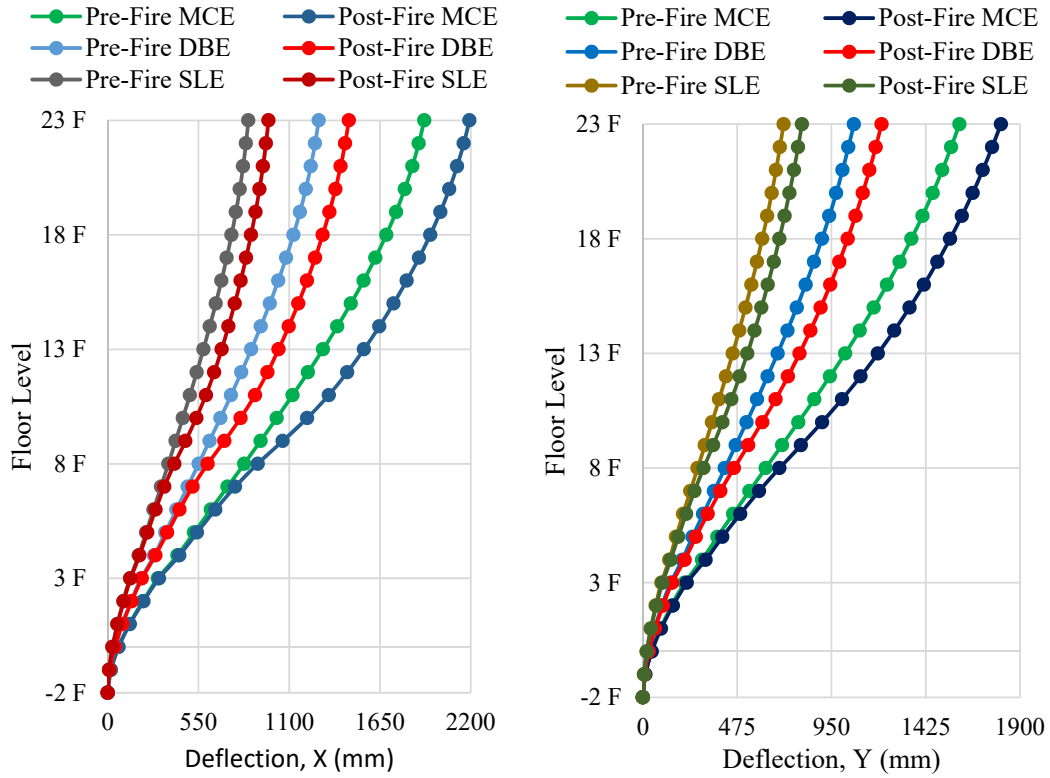
Fig 5.9: Maximum Deflection.

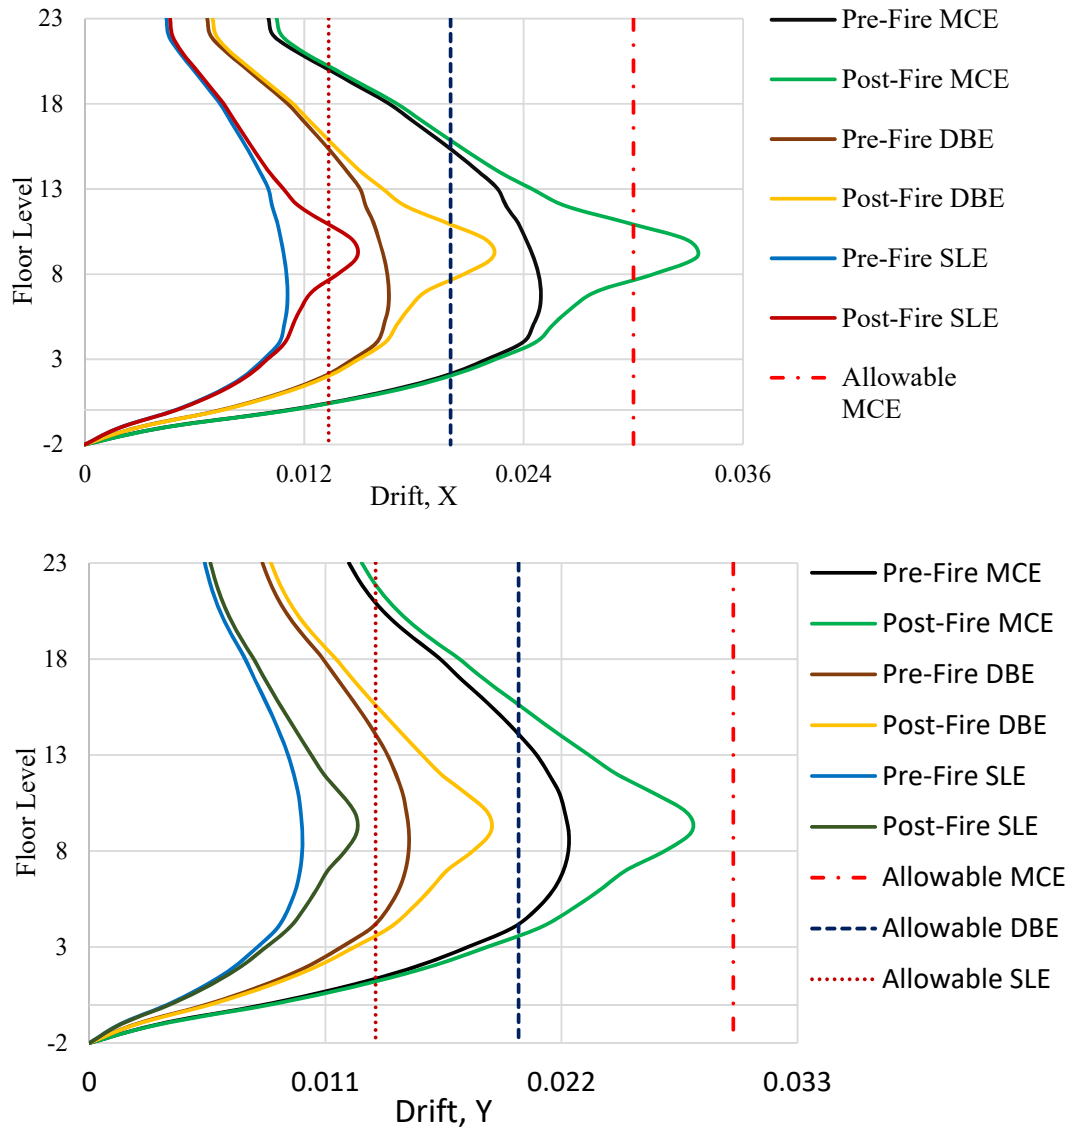
Fig 5.10: Storey drift.

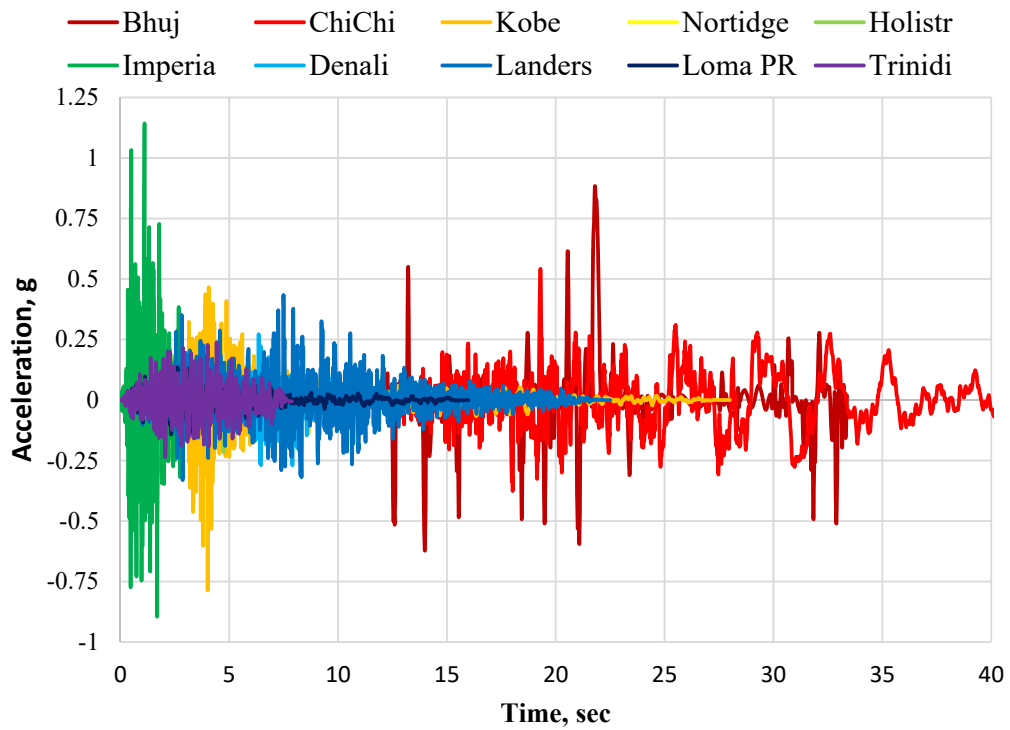
Fig 5.14: Time history functions of ten different ground motions.

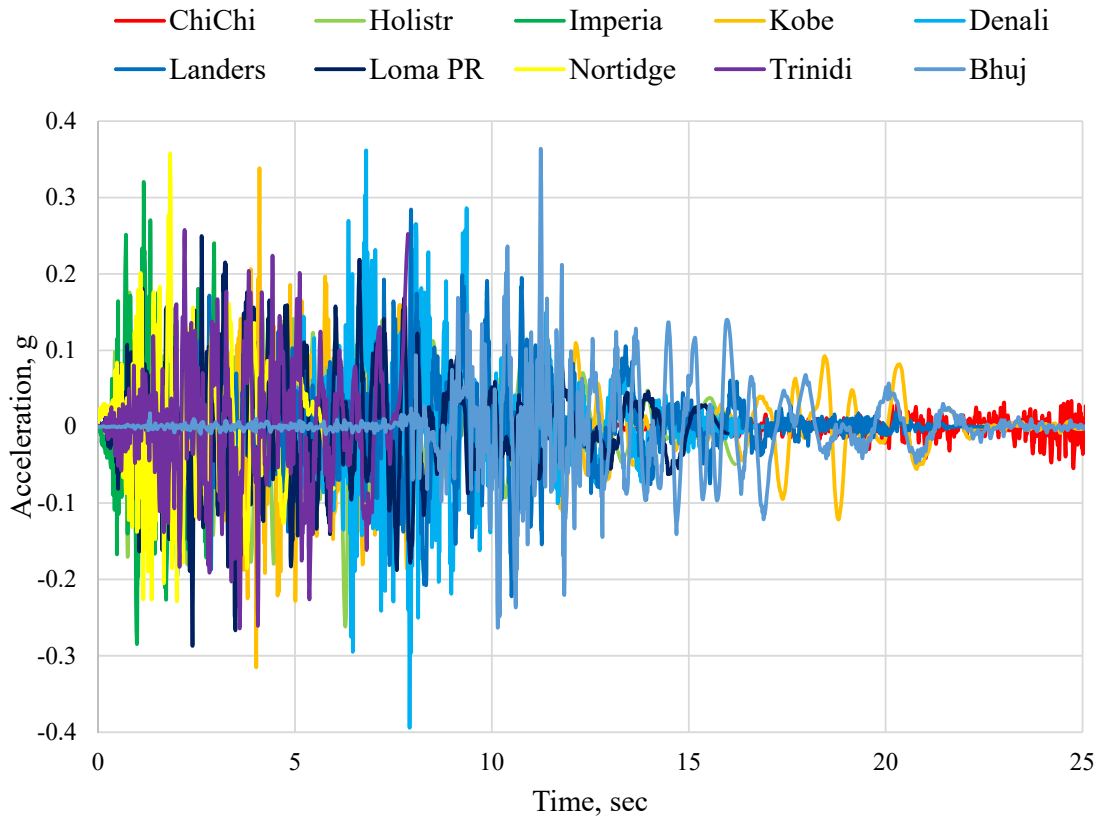
Fig 5.15: Scaled Time history function- 2475 Years.

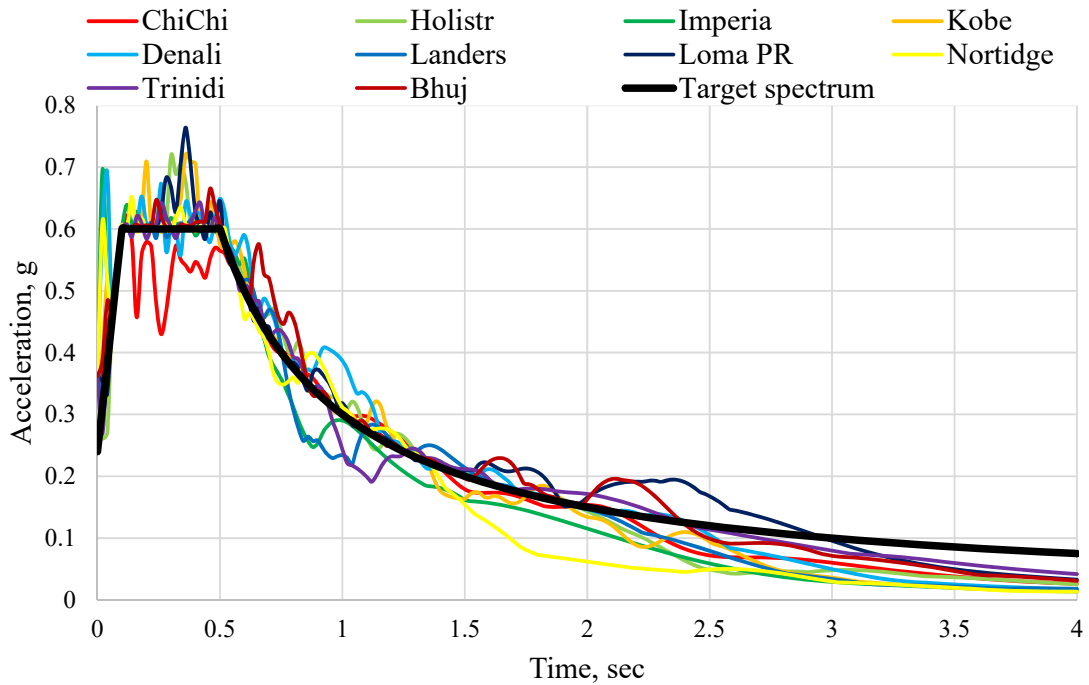
Fig 5.16: Scaled Response Spectrum- 2475 Years.

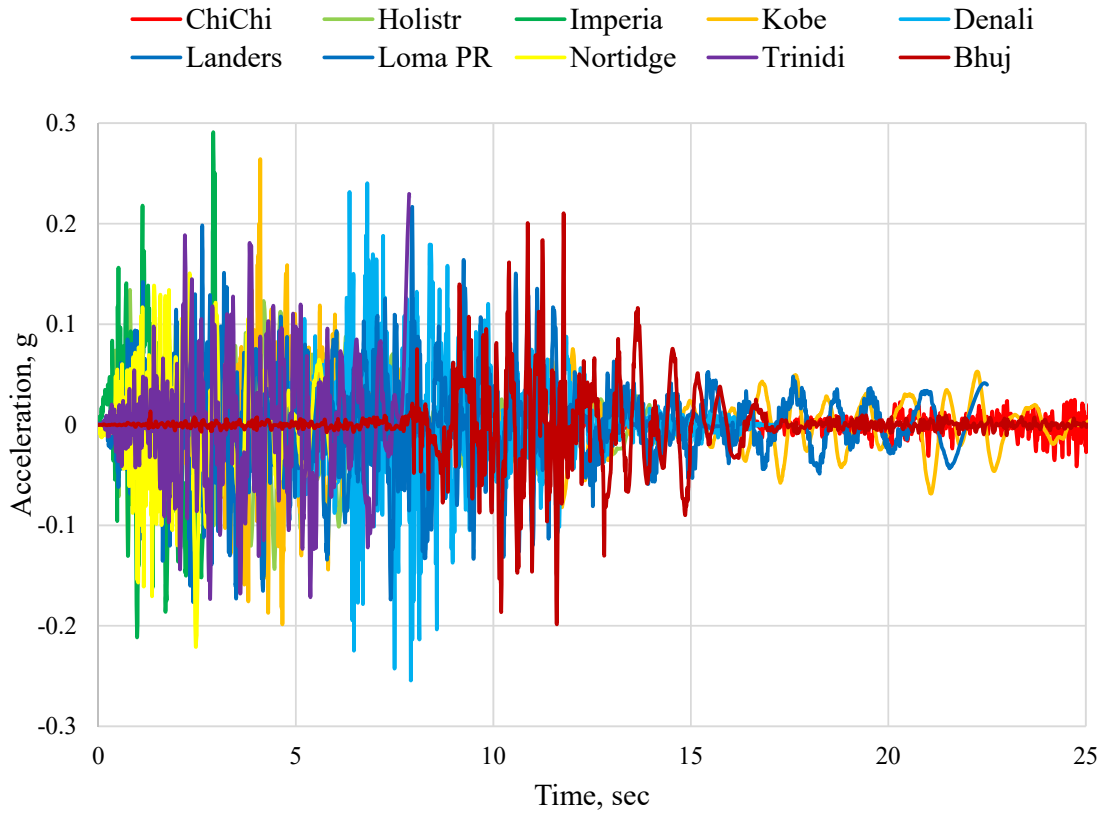
Fig 5.17: Scaled Time history function- 475 Years.

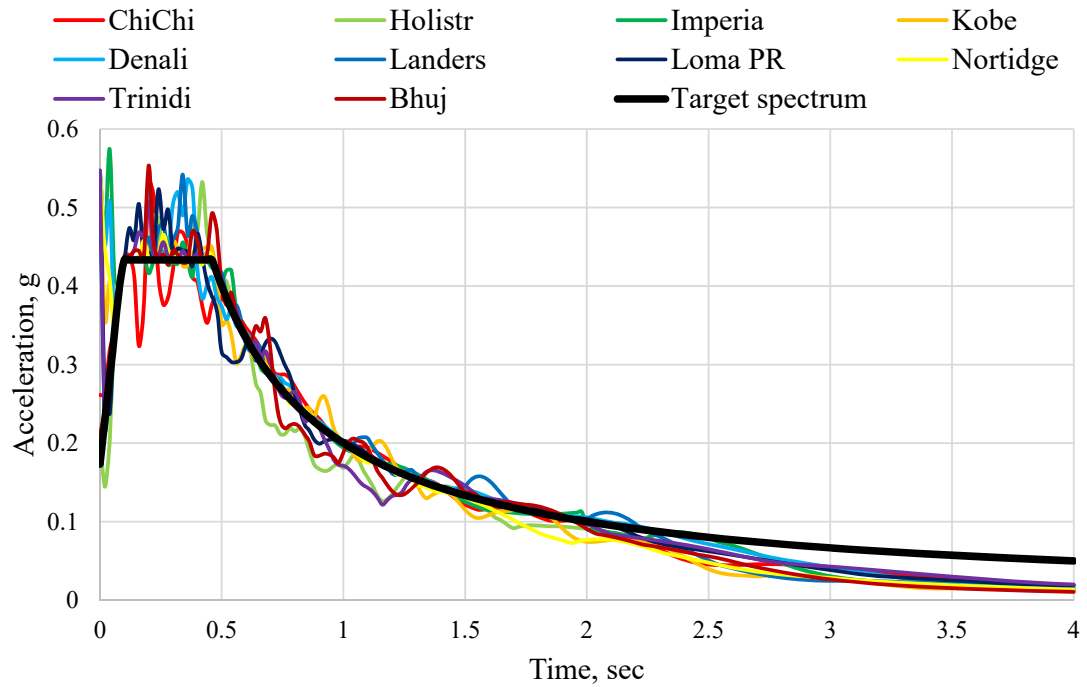
Fig 5.18: Scaled Response Spectrum- 475 Years.

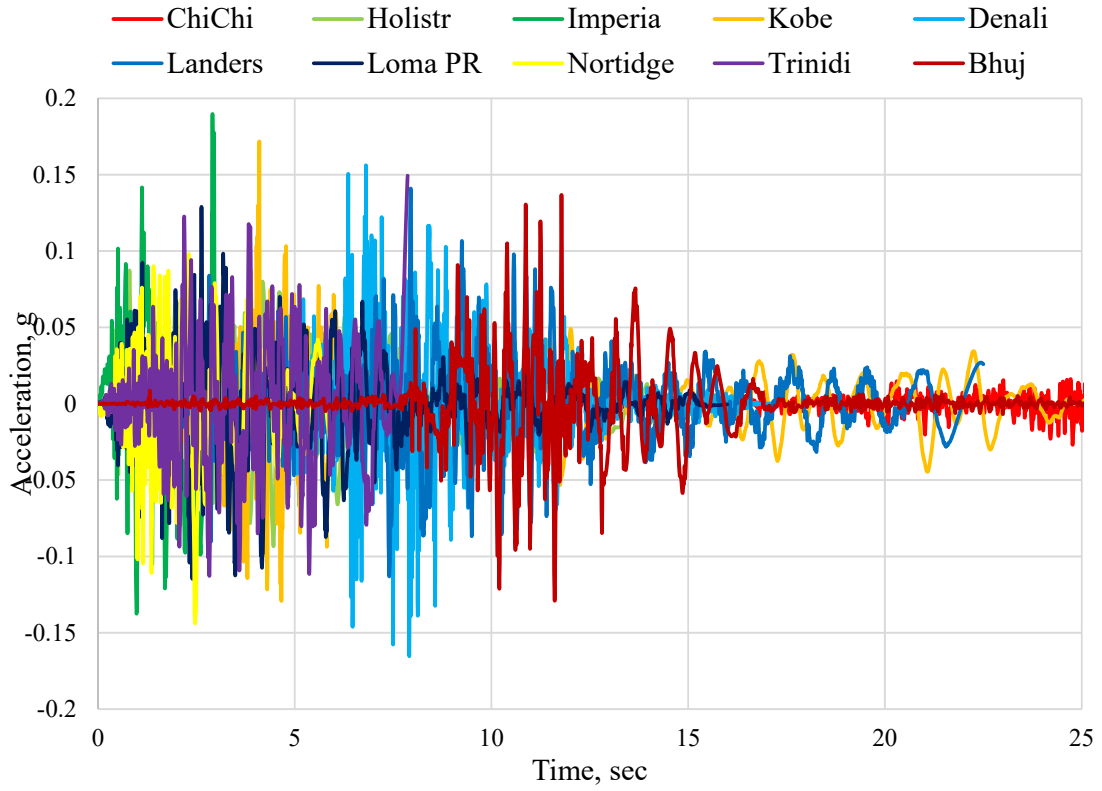
Fig 5.19: Scaled Time History Function- 43 Years.

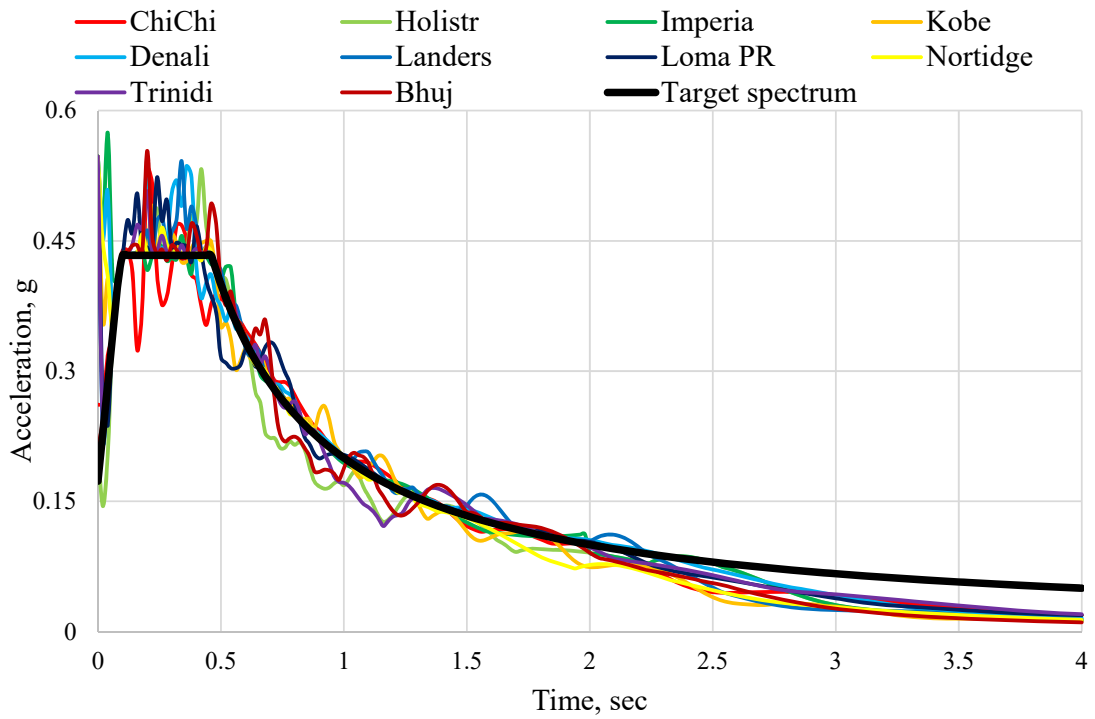
Fig 5.20: Scaled Response Spectrum- 43 Years.
