SEISMIC PERFORMANCE EVALUATION OF A FIRE-DAMAGED HIGH-RISE BUILDING

M.Sc. ENGINEERING THESIS

**DEPARTMENT OF CIVIL ENGINEERING
MILITARY INSTITUTE OF SCIENCE AND TECHNOLOGY
DHAKA, BANGLADESH**

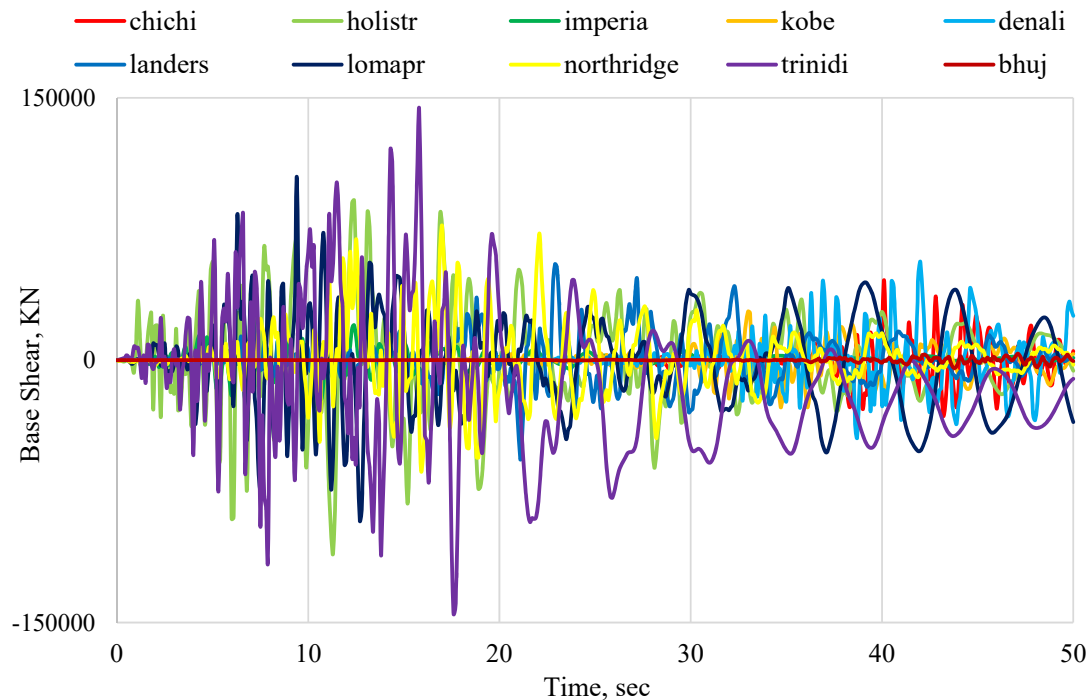
Fig 5.21: Base shear at different GMs for pre-fire MCE condition.

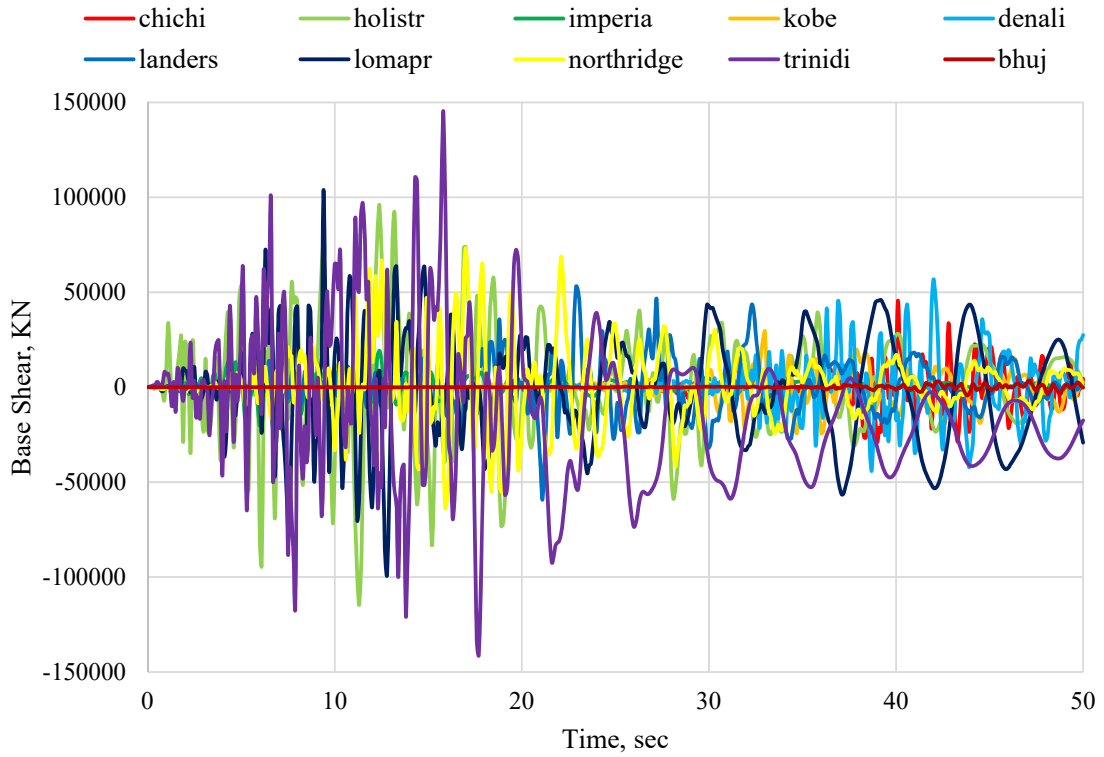
Fig 5.22: Base shear at different GMs for post-fire MCE condition.

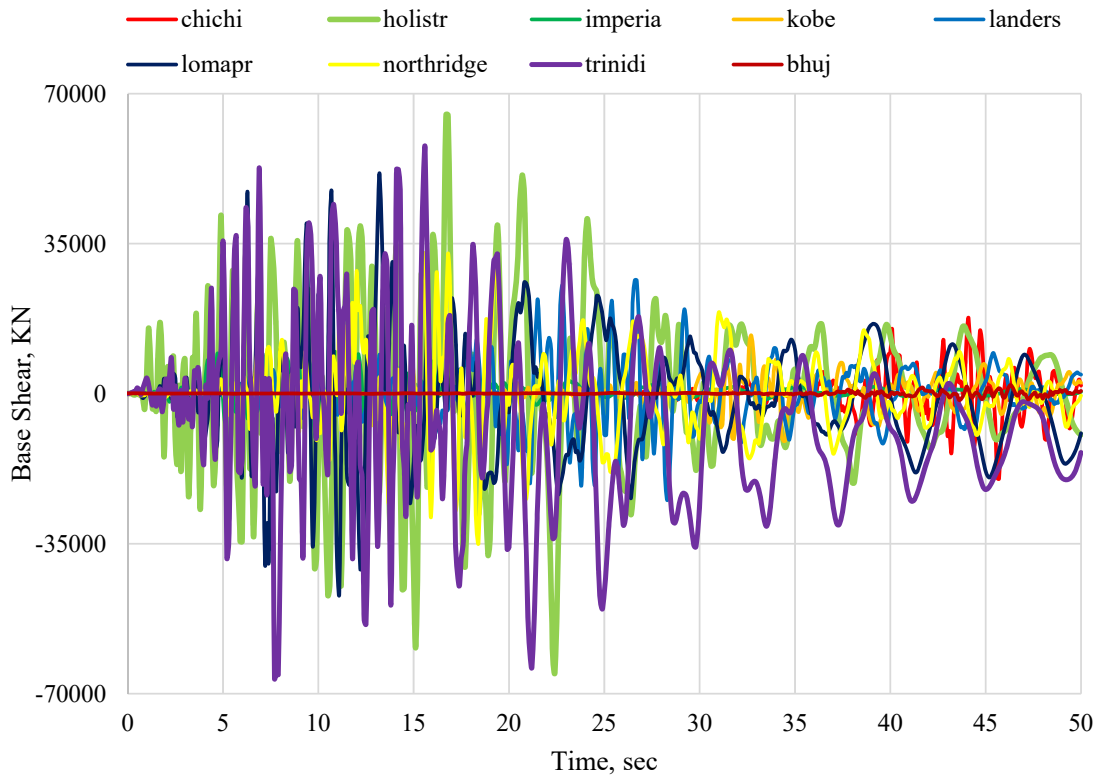
Fig 5.23: Base shear at different GMs for pre-fire DBE condition.

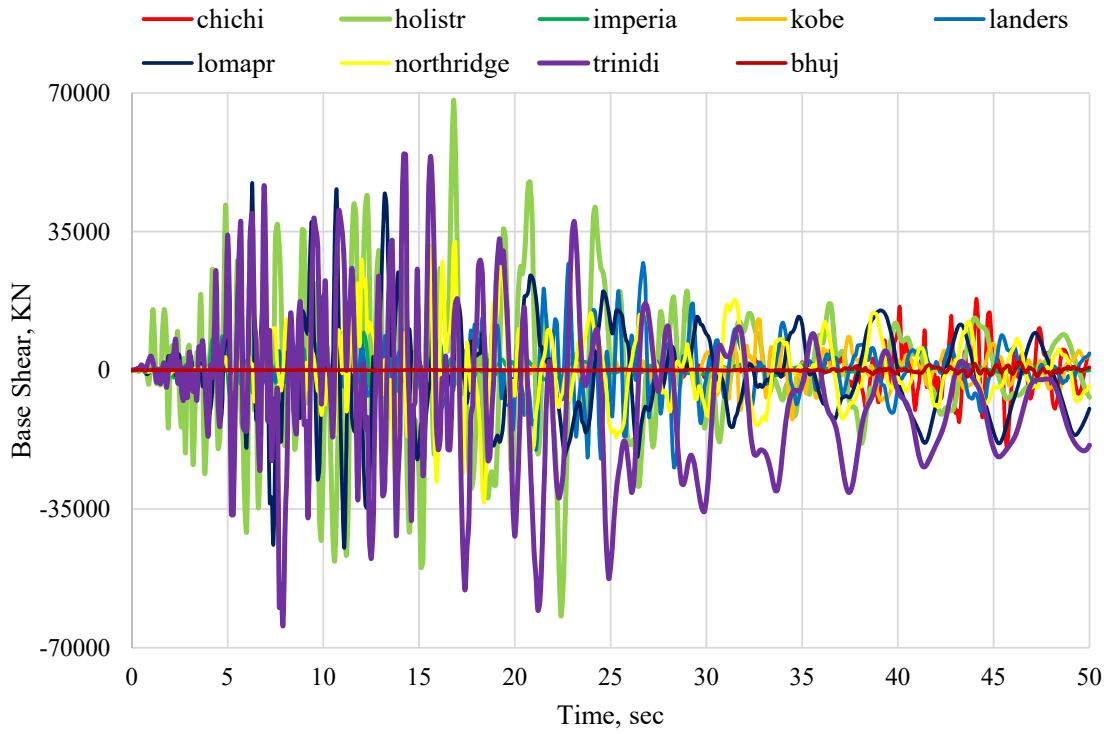
Fig 5.24: Base shear at different GMs for post-fire DBE condition.

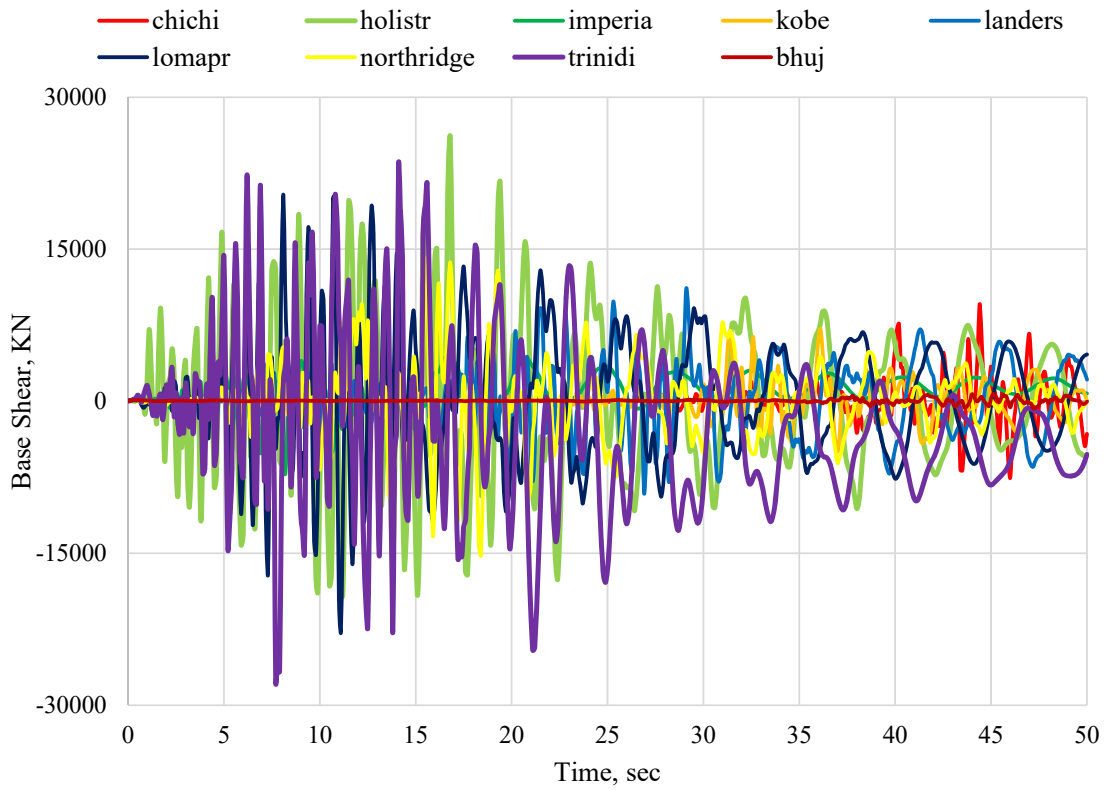
Fig 5.25: Base shear at different GMs for pre-fire SLE condition.

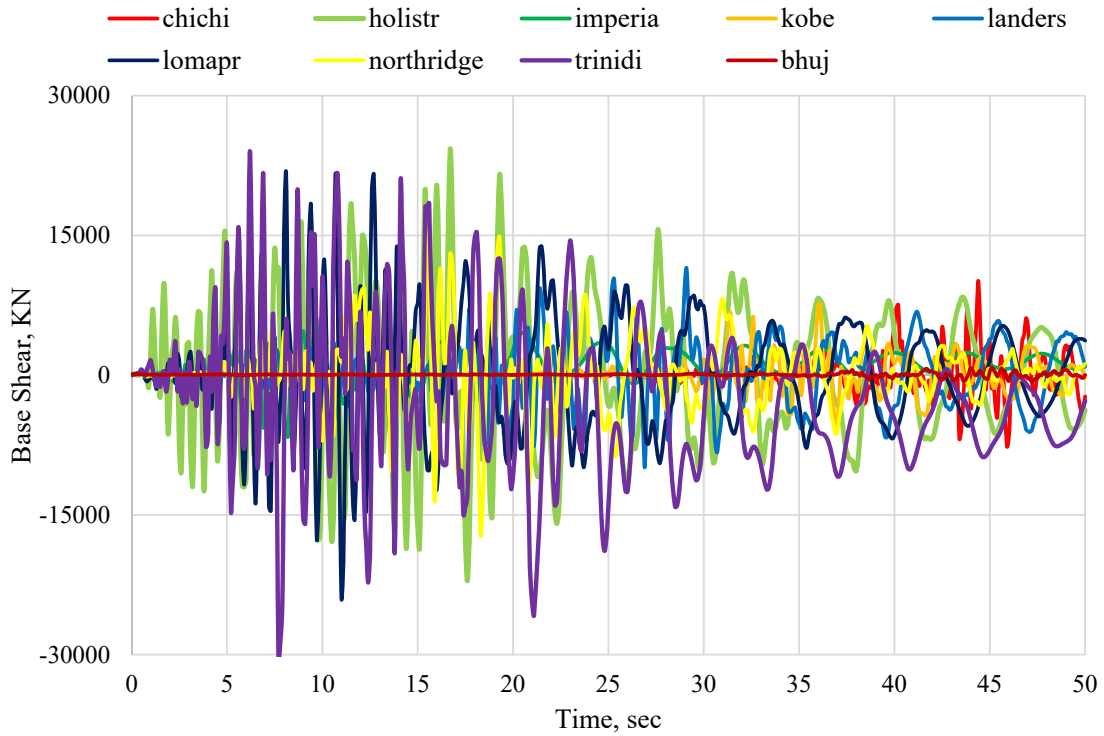
Fig 5.26: Base shear at different GMs for post-fire SLE condition.

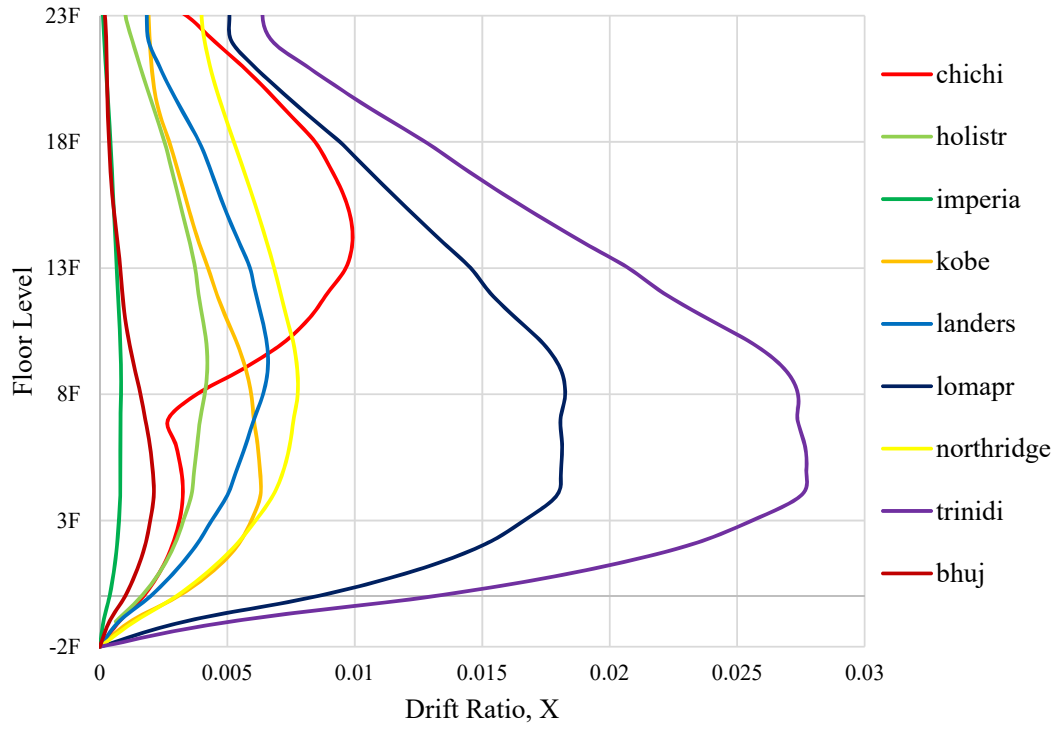
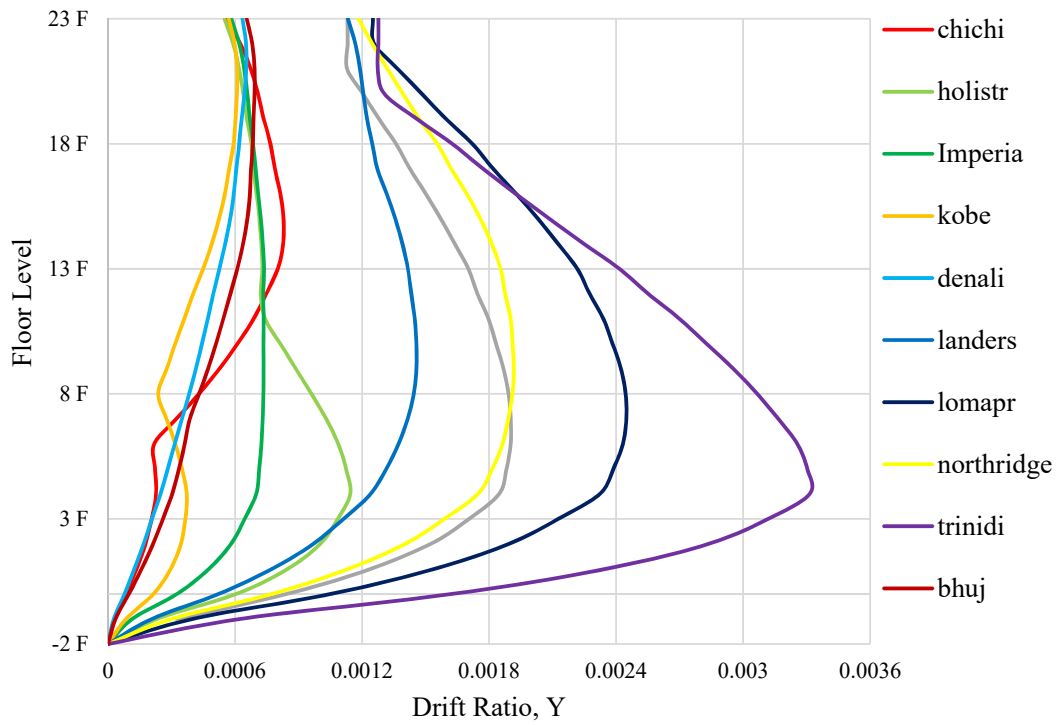
Fig 5.27: Storey drift ratio for different GMs (post-fire MCE condition).

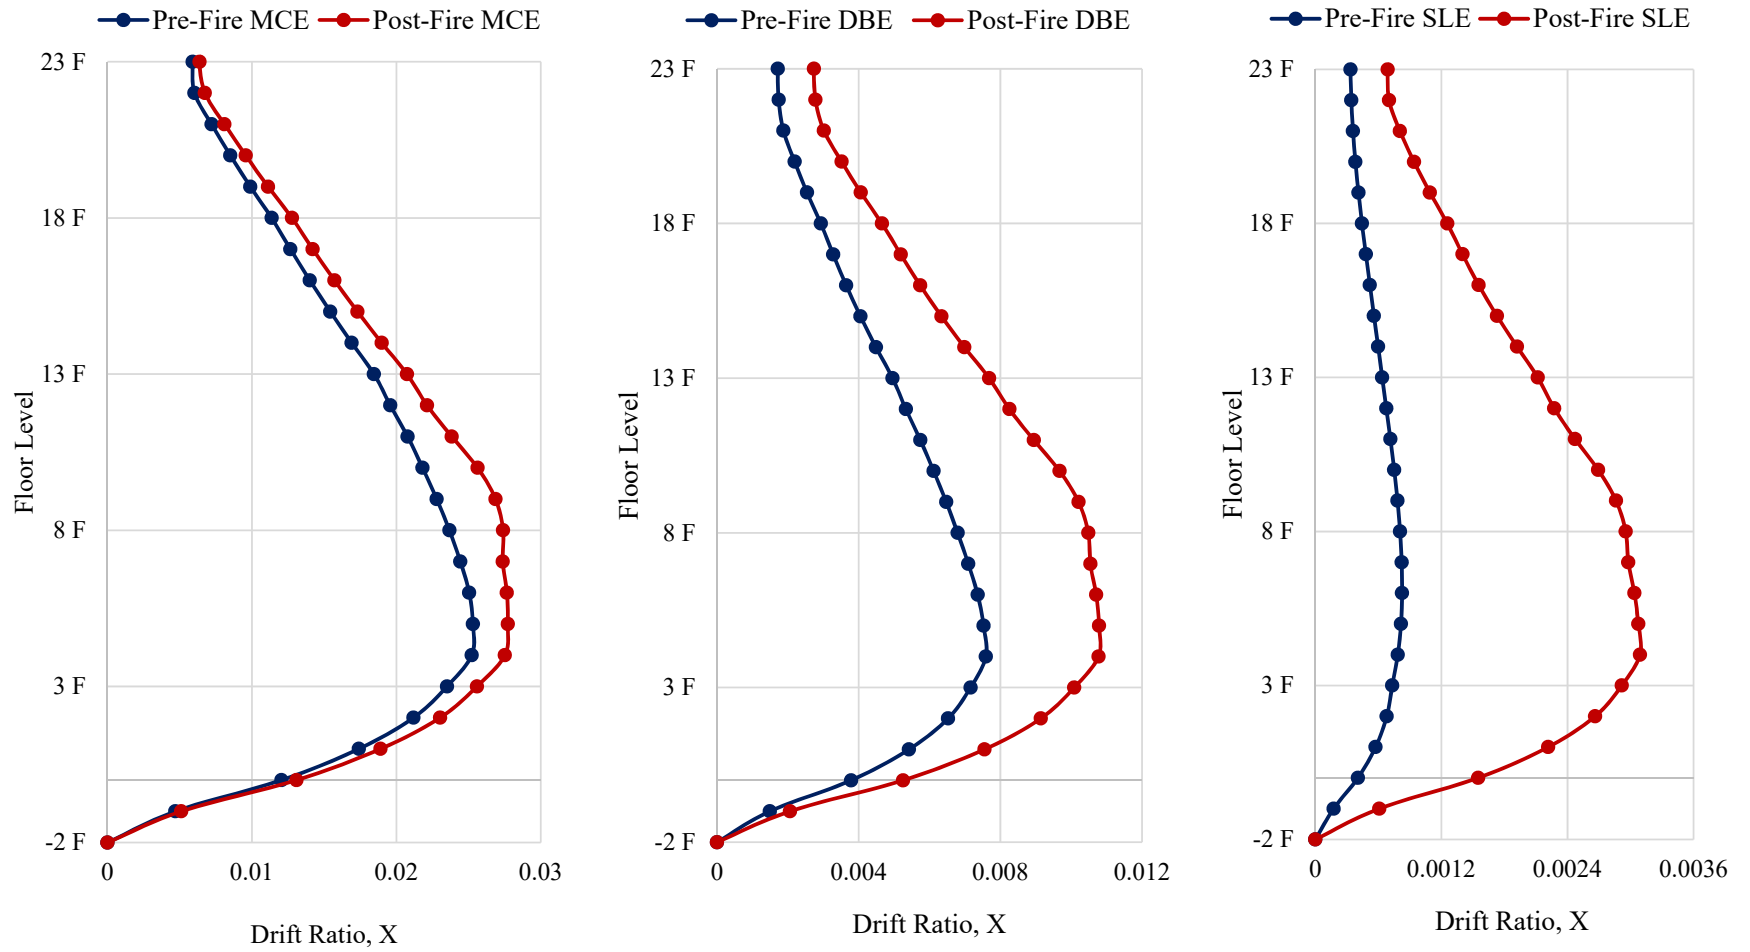
Fig 5.28: Maximum storey drift ratio in the X direction for MCE, DBE & SLE condition (for Trinidad GMs).

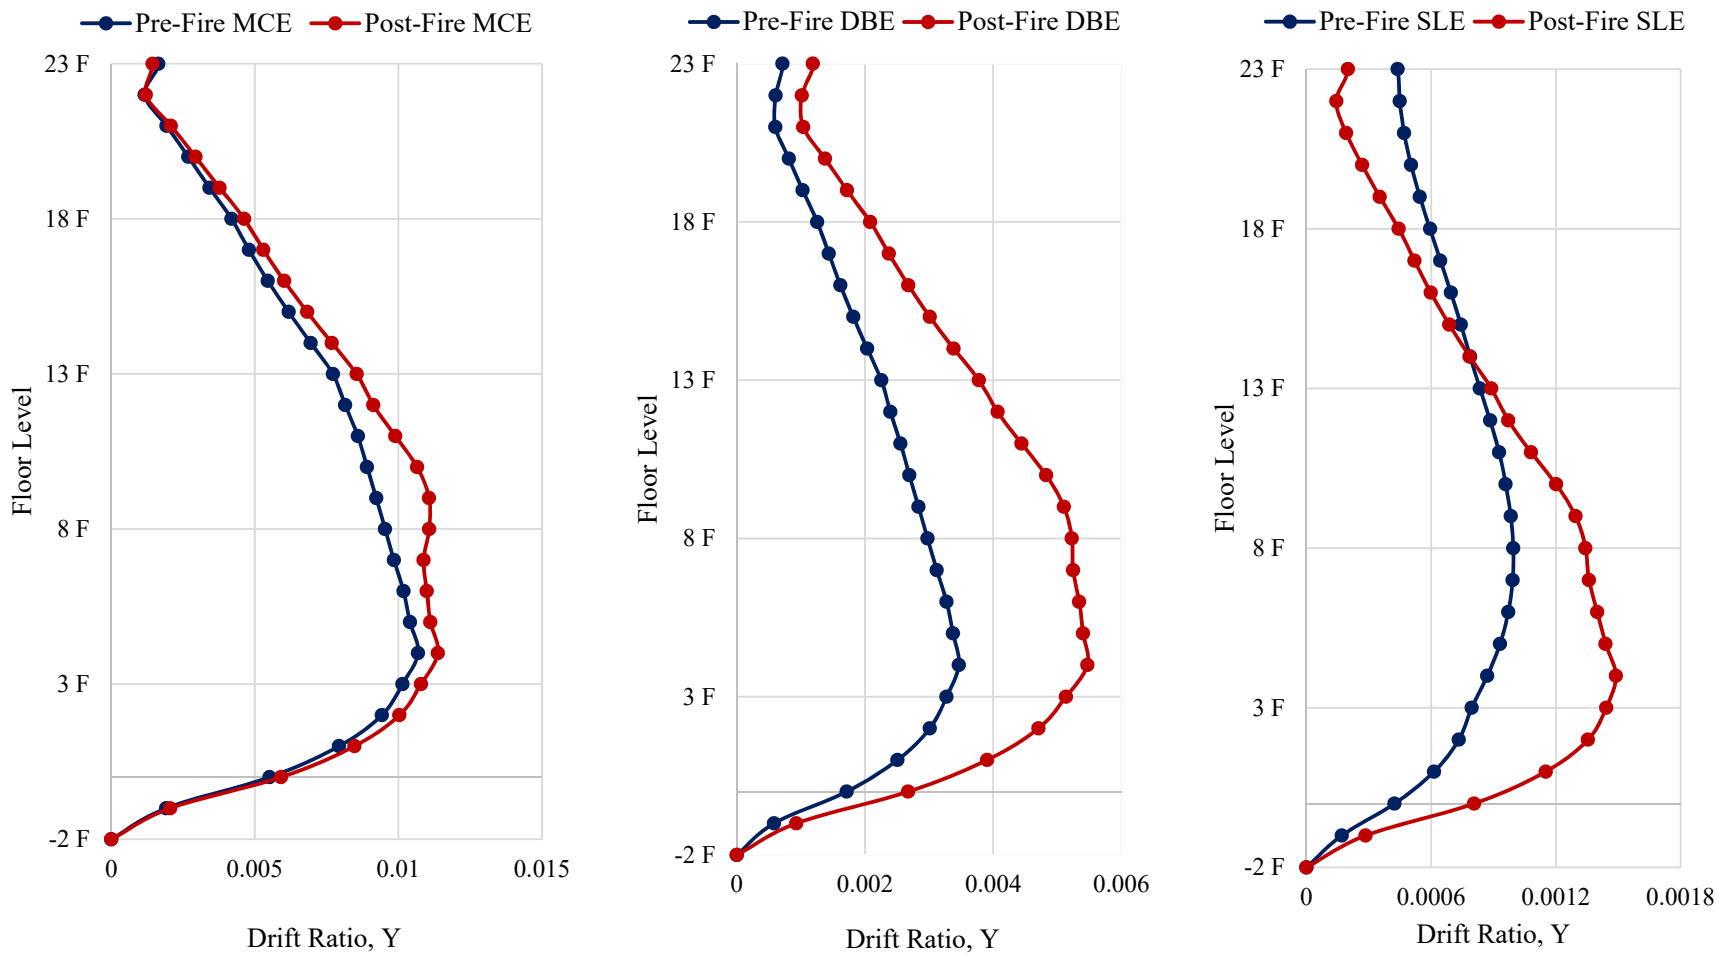
Fig 5.29: Maximum storey drift ratio in the Y direction for MCE, DBE & SLE condition (for Trinidad GMs).

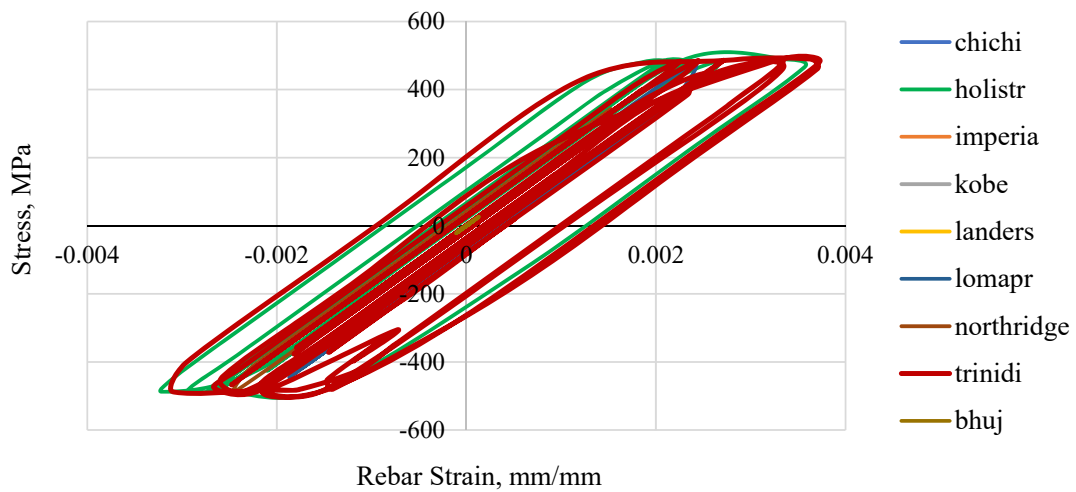
Fig 5.30: Rebar stress-strain curve for hinge W8H19 (7F), fiber-19.

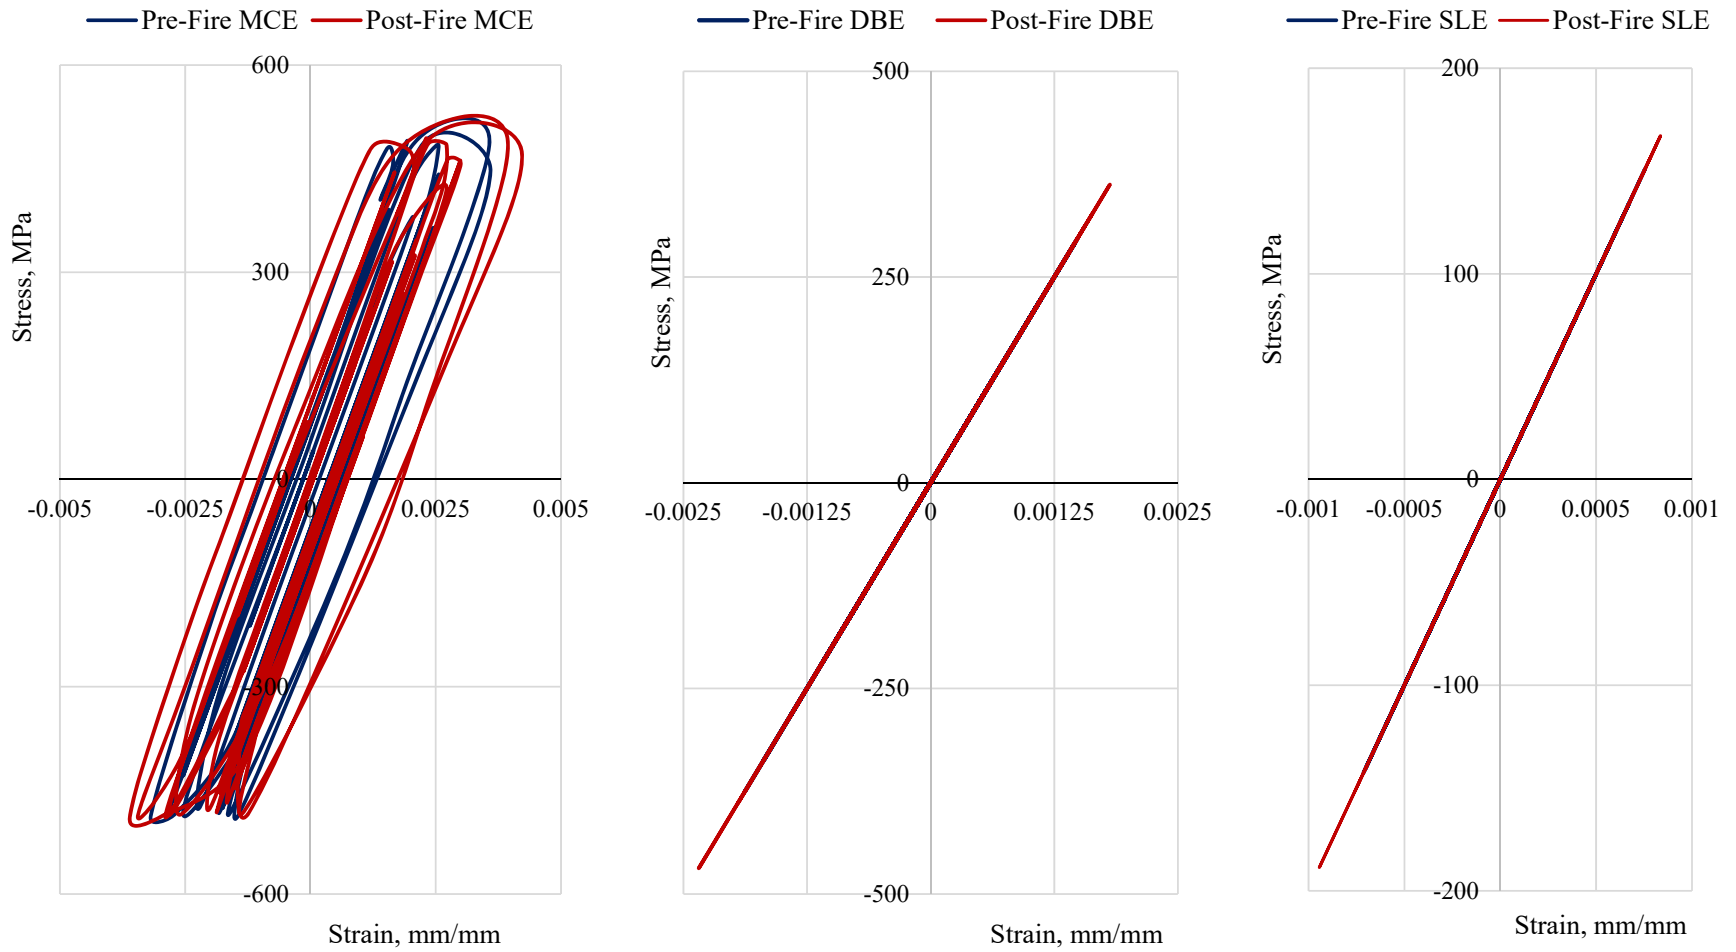
Fig 5.32: Rebar stress-strain curve for hinge W2H18 (8F), fiber-19 for MCE, DBE & SLE condition.

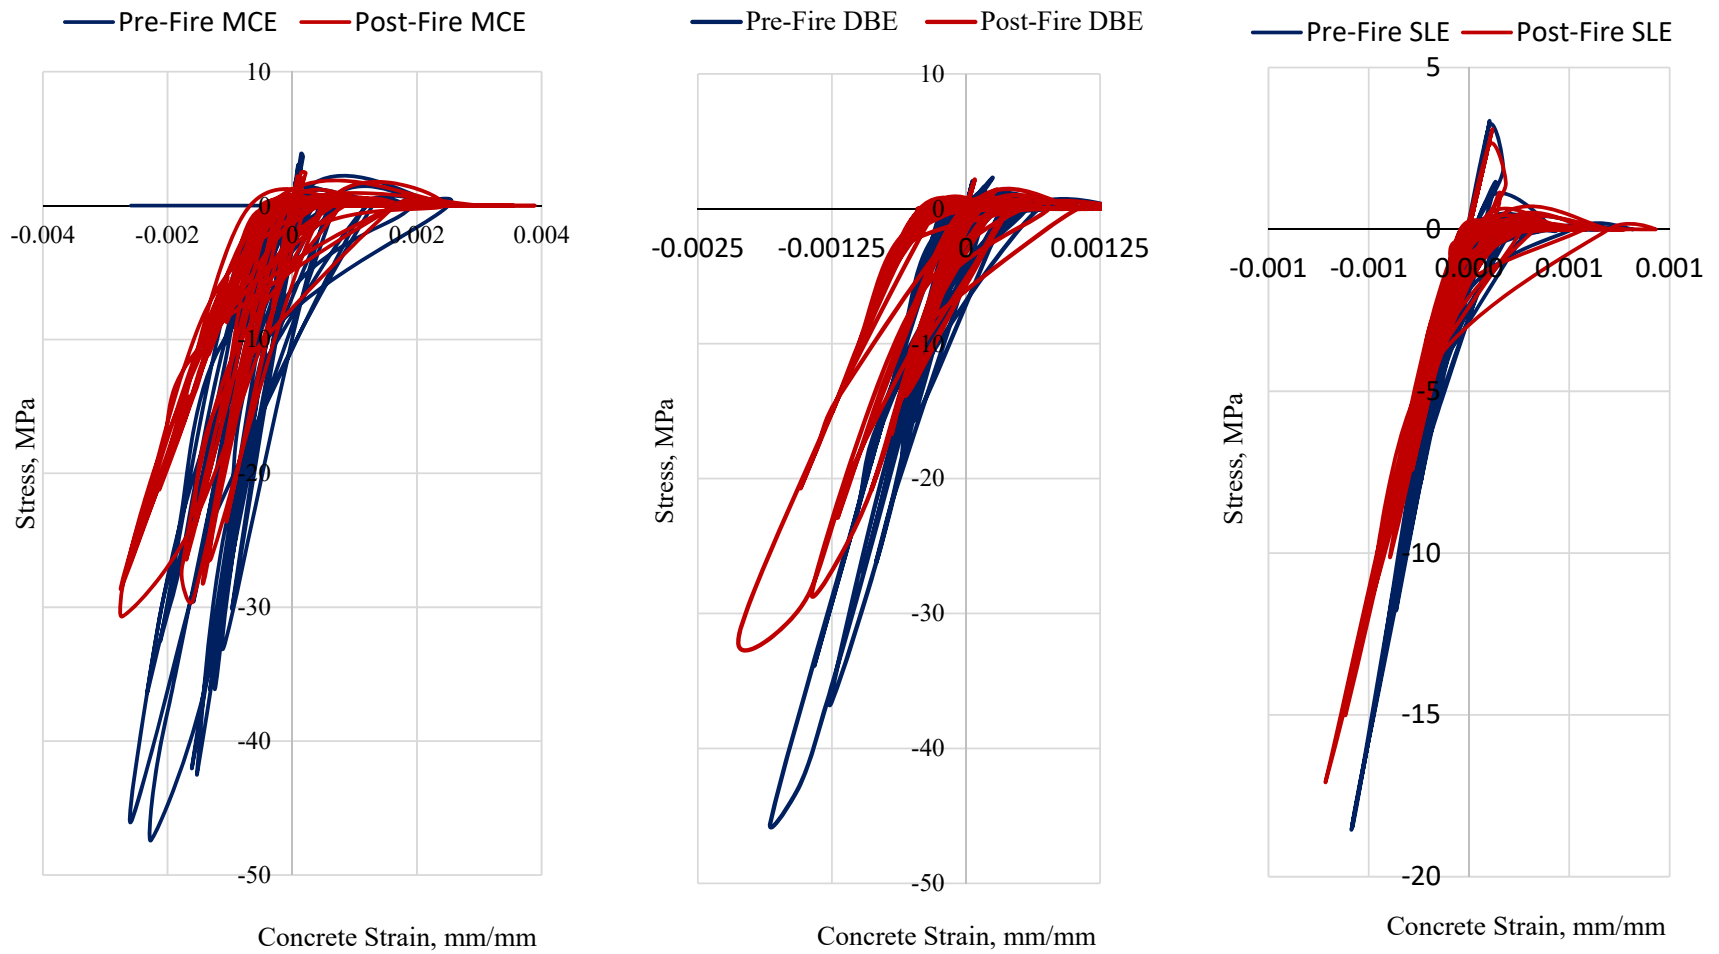
Fig 5.33: Concrete stress-strain curve for hinge W8H19 (7F), fiber-4 for MCE, DBE & SLE condition.

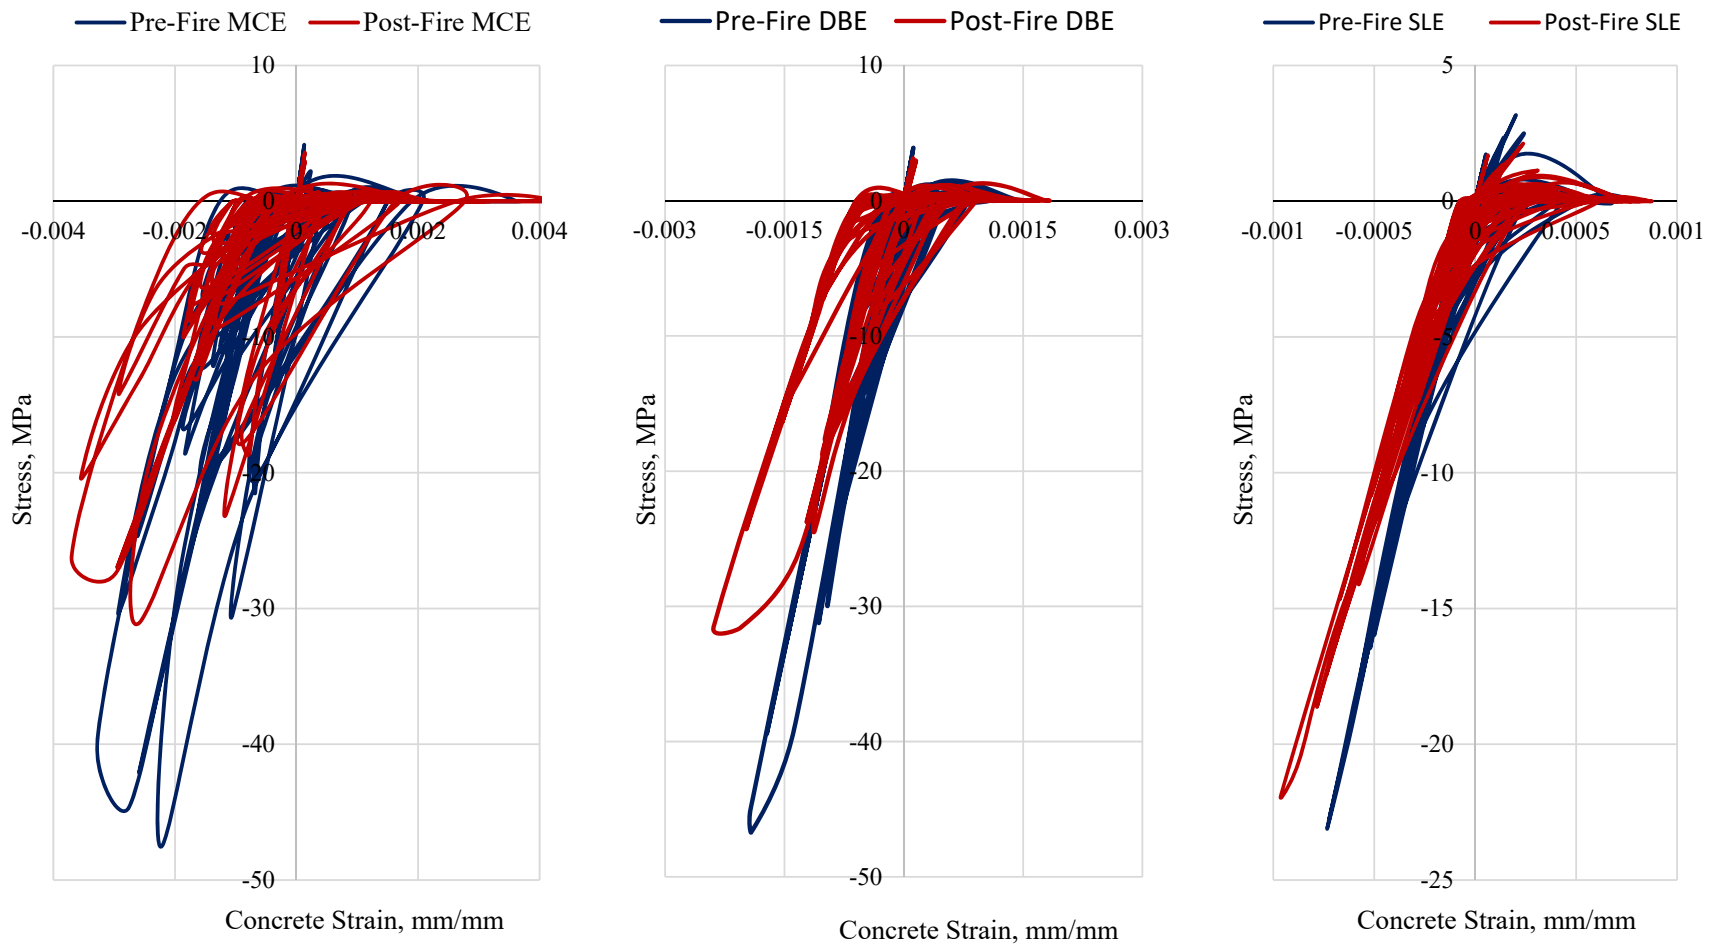
Fig 5.34: Concrete stress-strain curve for hinge W2H18 (8F), fiber-17 for MCE, DBE & SLE condition.

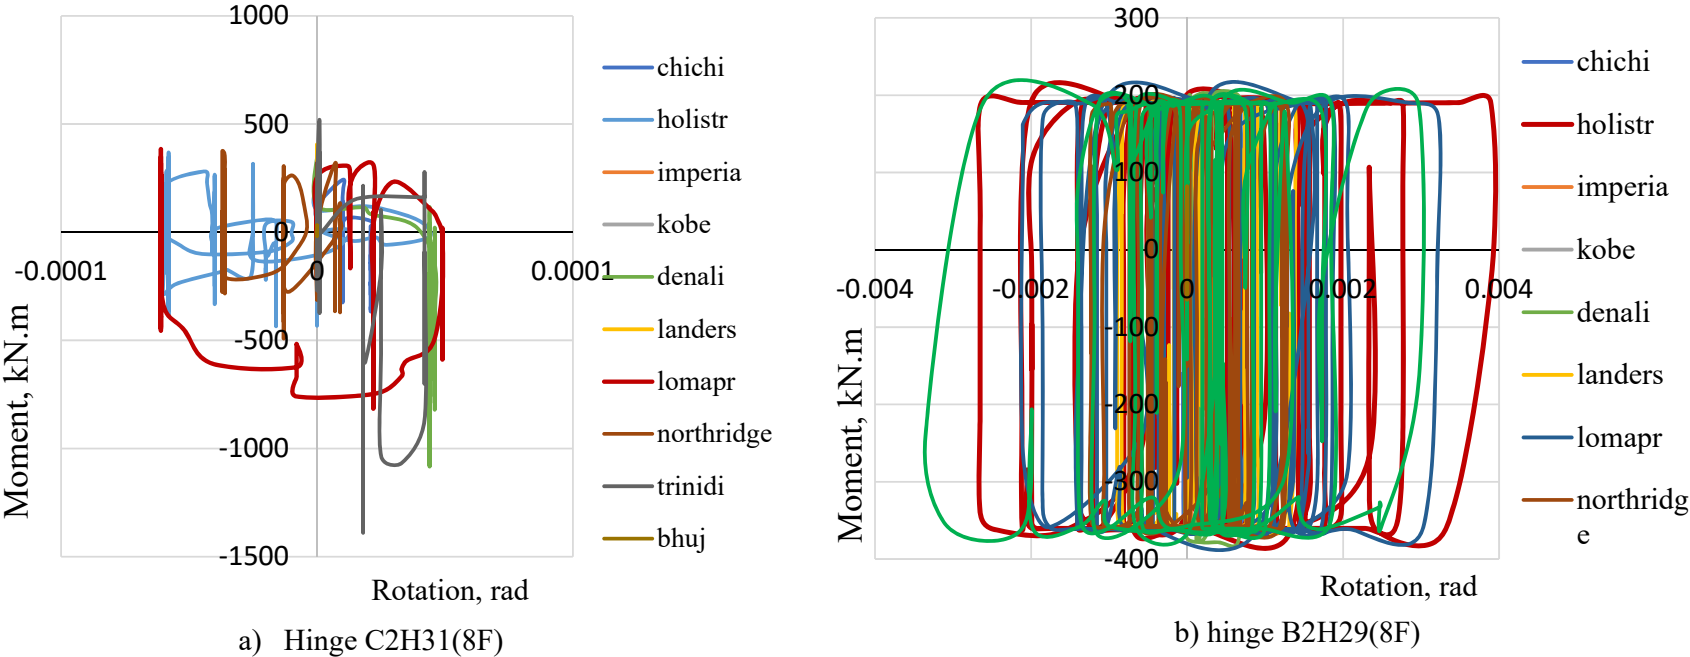
Fig 5.36: Hysteretic Response of Hinge for different GMs.

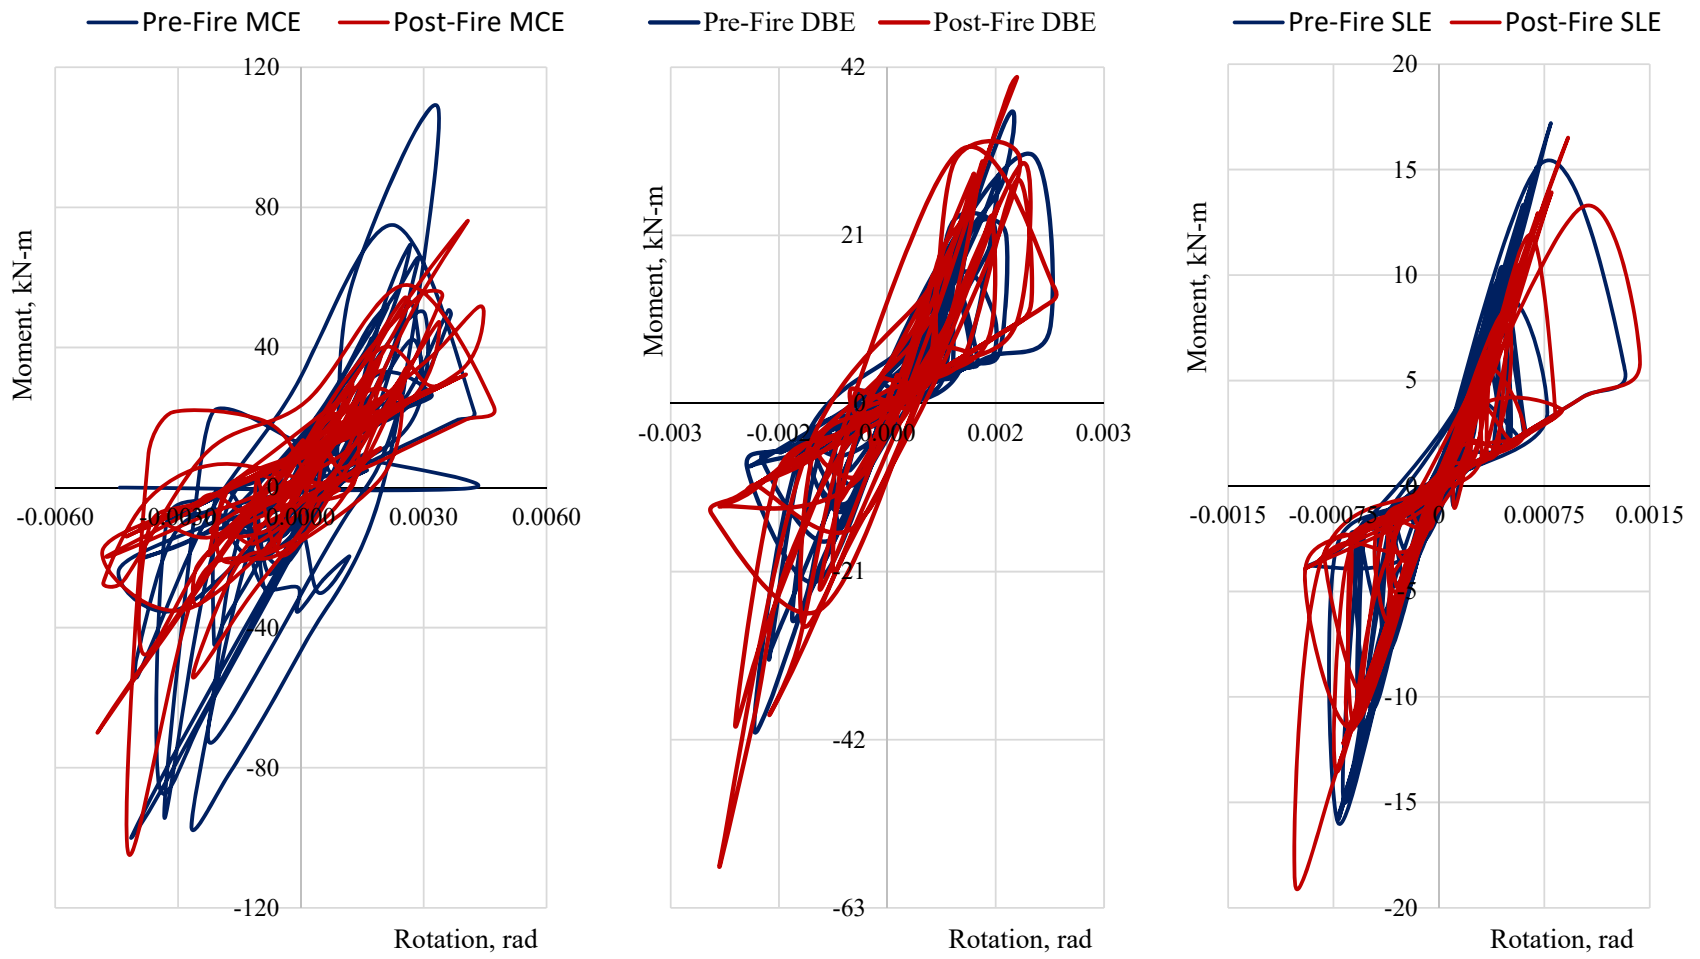
Fig 5.37: Shear wall moment rotation curve for hinge W8H19 (7F), for MCE, DBE & SLE condition.

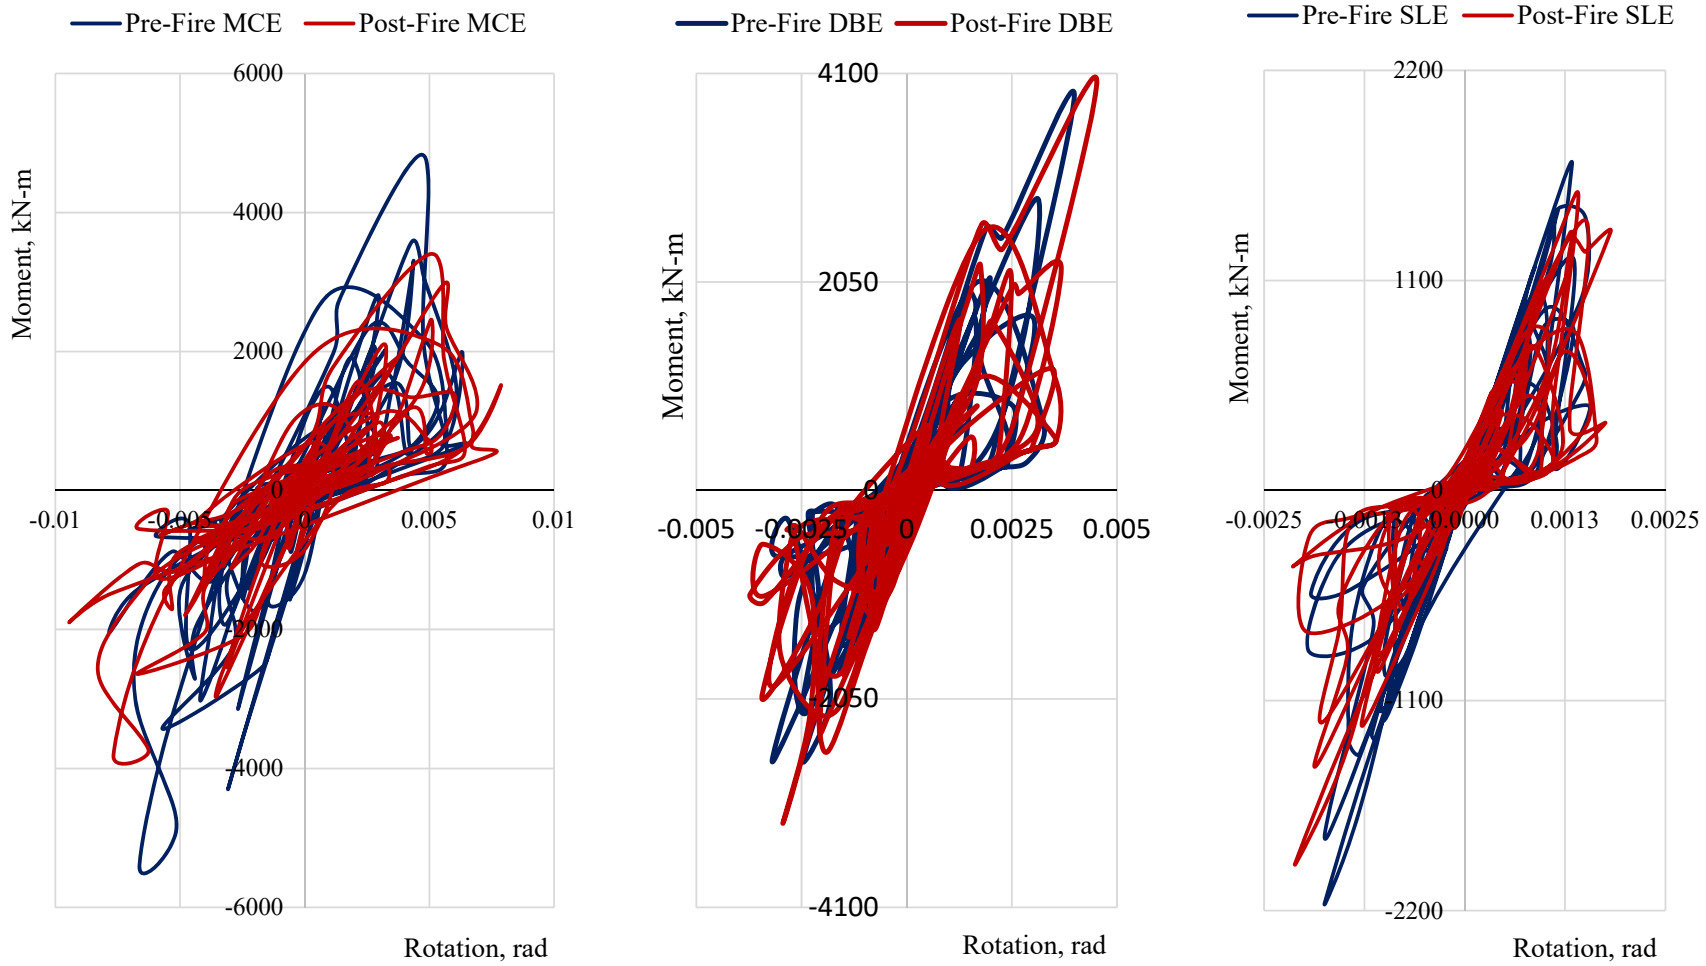
Fig 5.38: Shear wall moment rotation curve for hinge W2H18 (8F), for MCE, DBE & SLE condition.

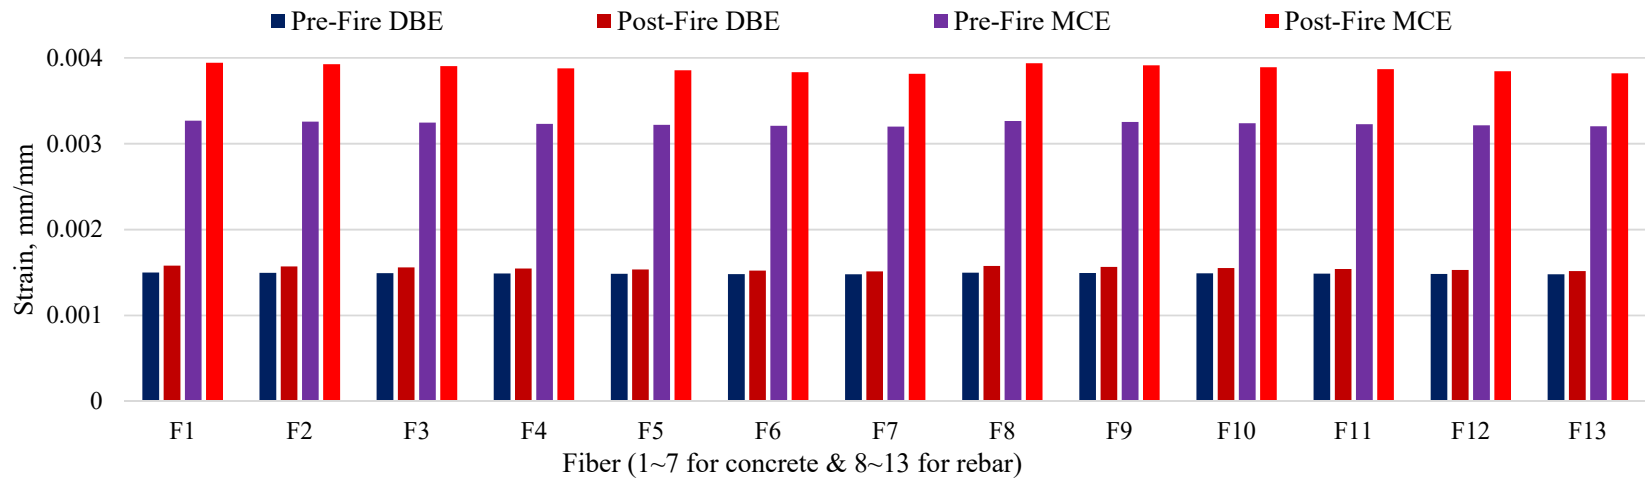
Fig 5.40: Comparative strain for various fibers of concrete and rebar for W8H19 (7F) hinge at MCE & DBE condition.

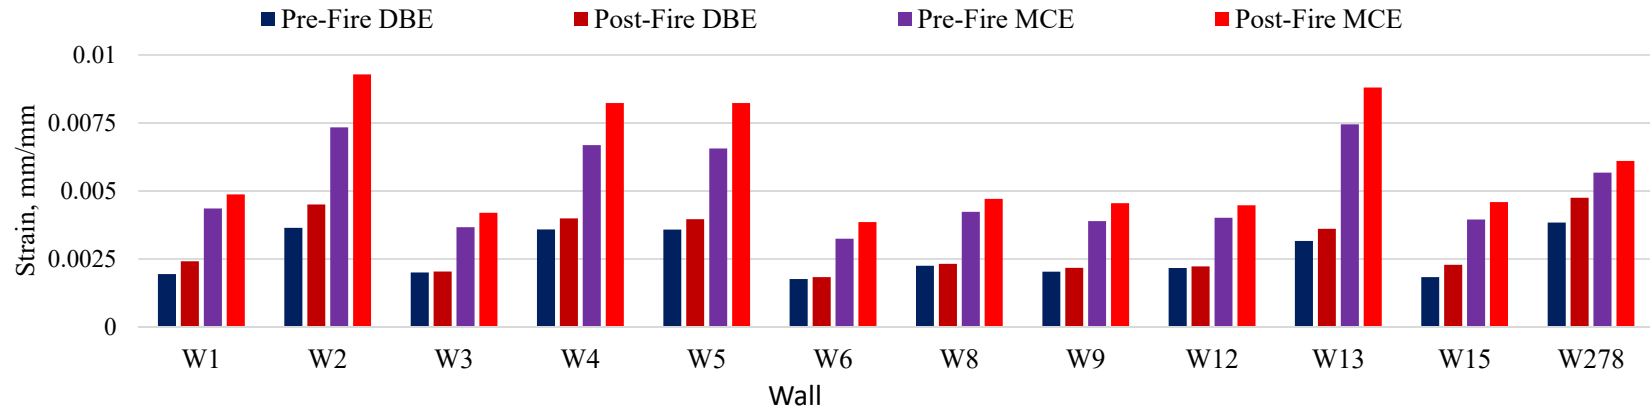
Fig 5.41: Comparative rotation of various wall hinges of 7th floor at MCE & DBE condition.

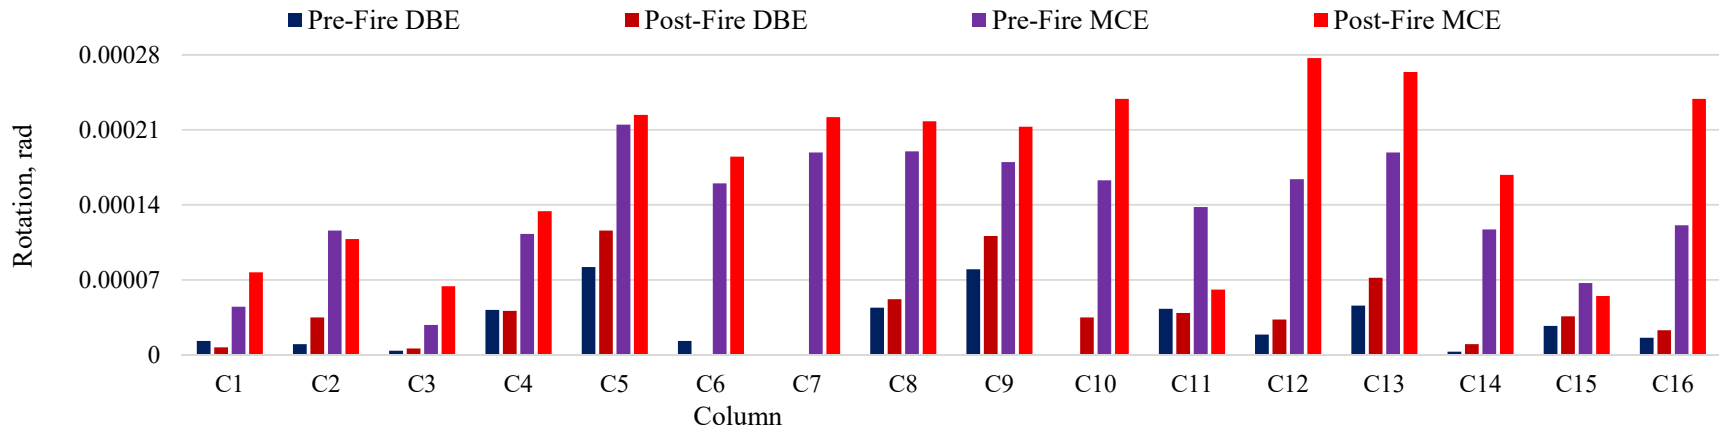
Fig 5.42: Comparatives of column hinge (W8H19-8F) rotation for MCE & DBE condition.

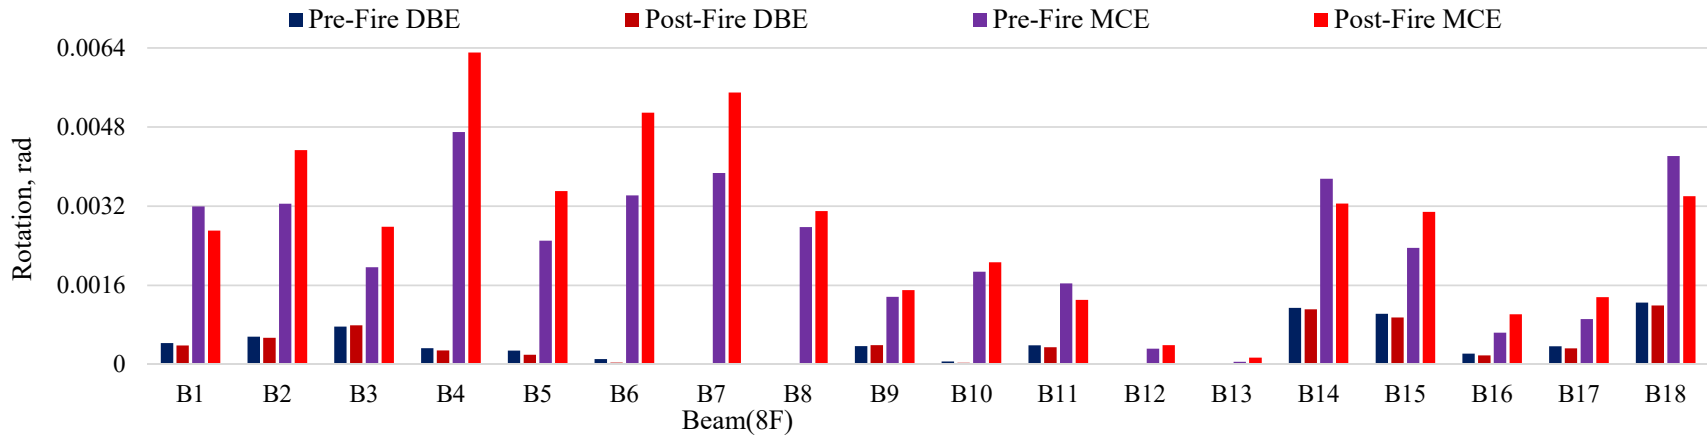
Fig 5.43: Comparatives of beam (8F) hinge rotation for MCE & DBE condition.
